# Your survey report

160 Dartmath Road, London, United  
Kingdom, SE22 3LQ

21/01/2025

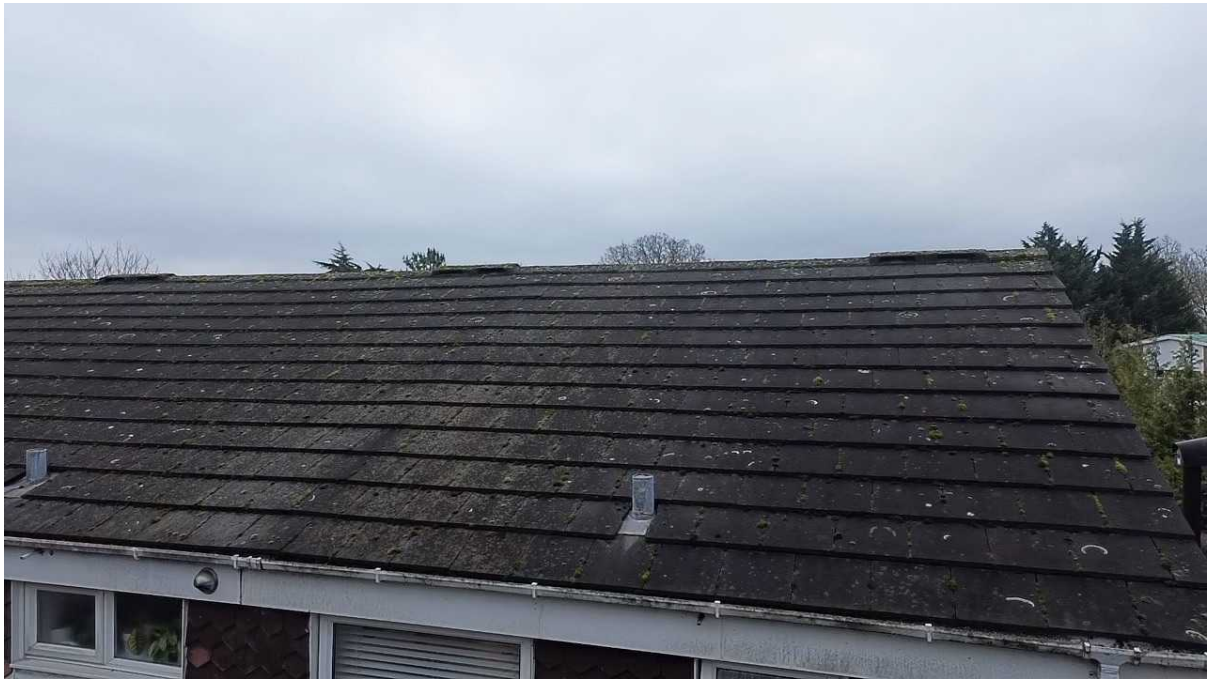
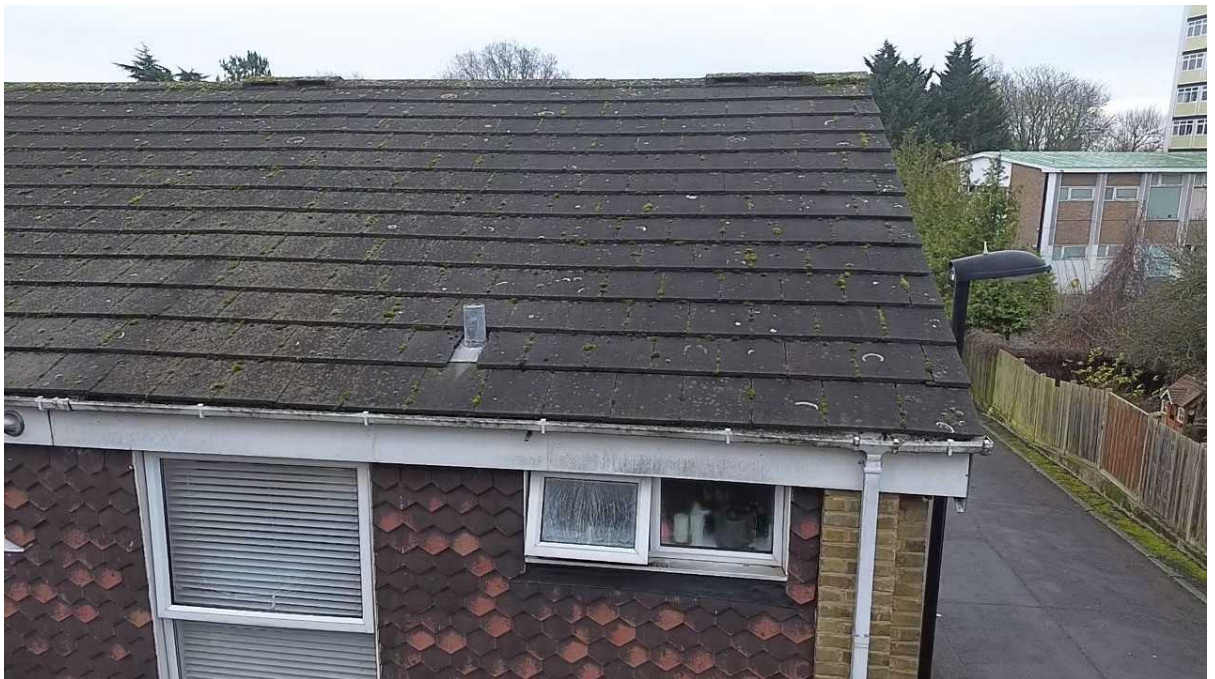
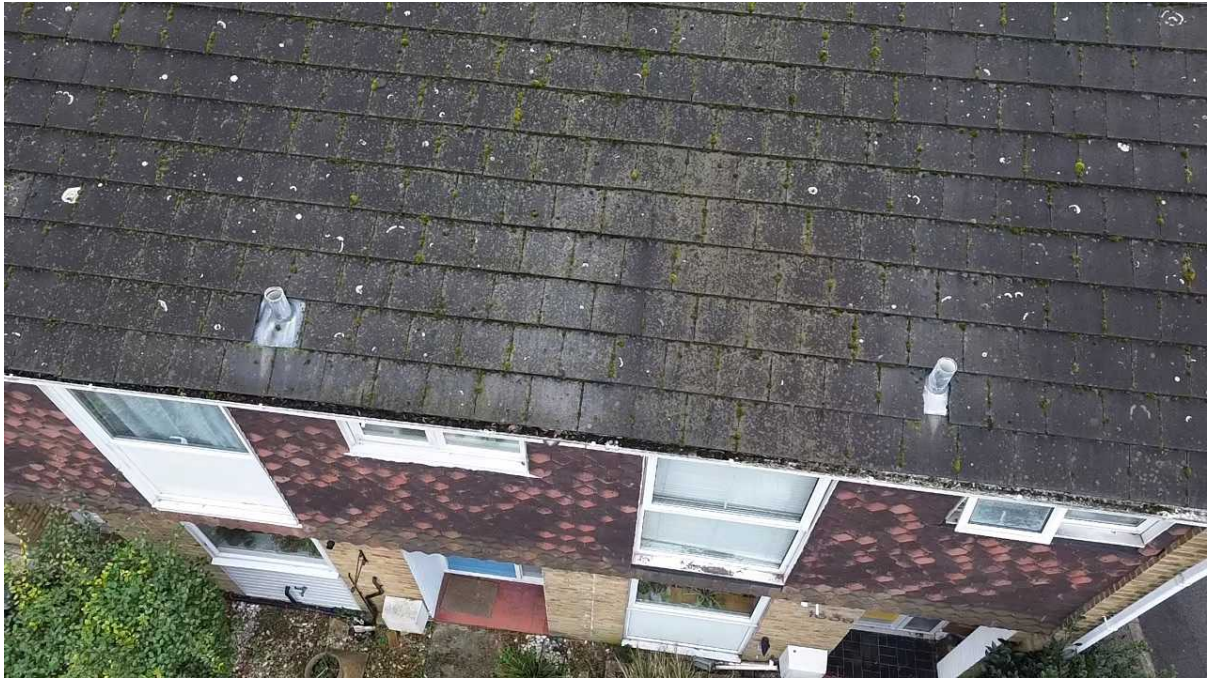
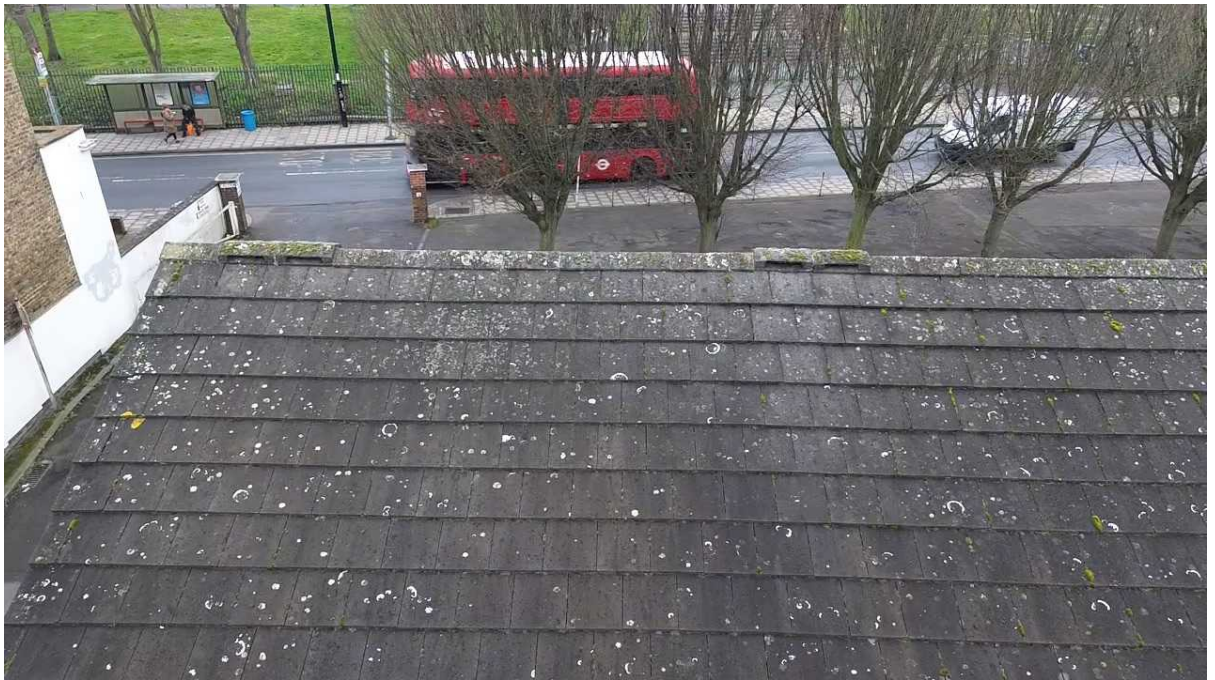
The roof is covered with concrete tiles, which appear to be in good condition overall. Moss is present on some of the tiles, which should be monitored and cleared to prevent water retention and potential damage over time. There are no missing tiles, and the ridge line remains straight with ridge tiles in good order. Ridge vents are properly installed and functioning as intended.

The fascia and bargeboards are in good order, and the verge mortar is intact with no signs of deterioration. The soffits are generally in good condition, except for the front corner soffit boards, which show slight degradation and looseness. These should be repaired or replaced to prevent further issues.

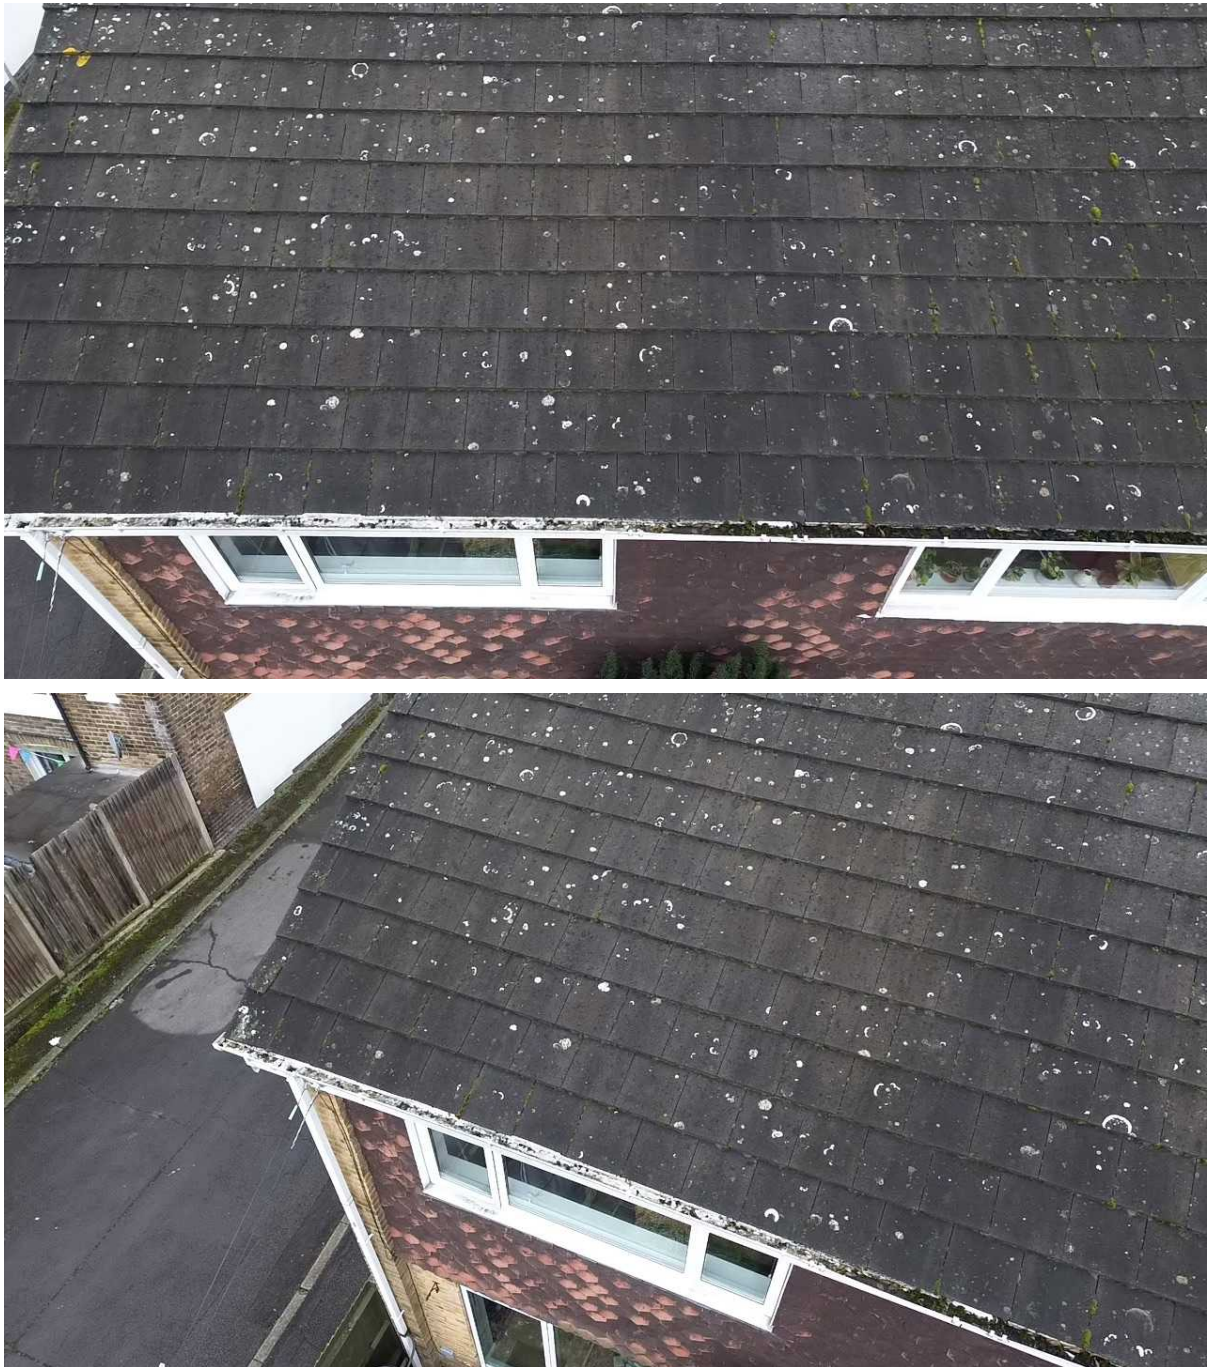
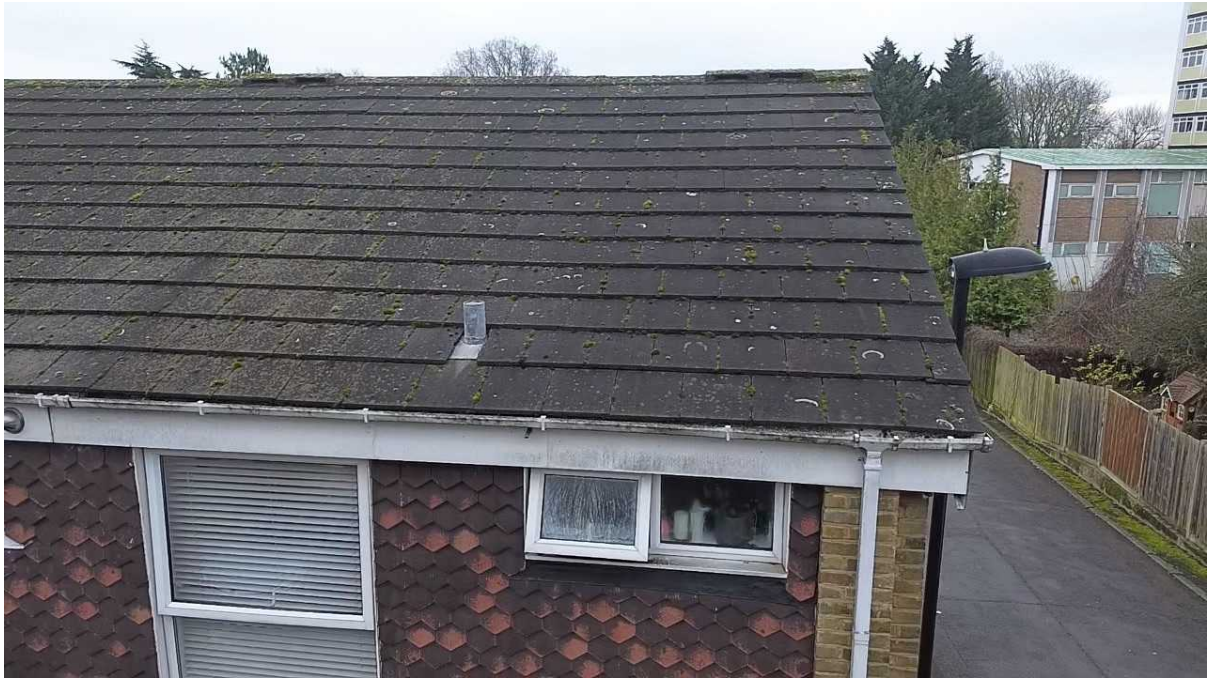
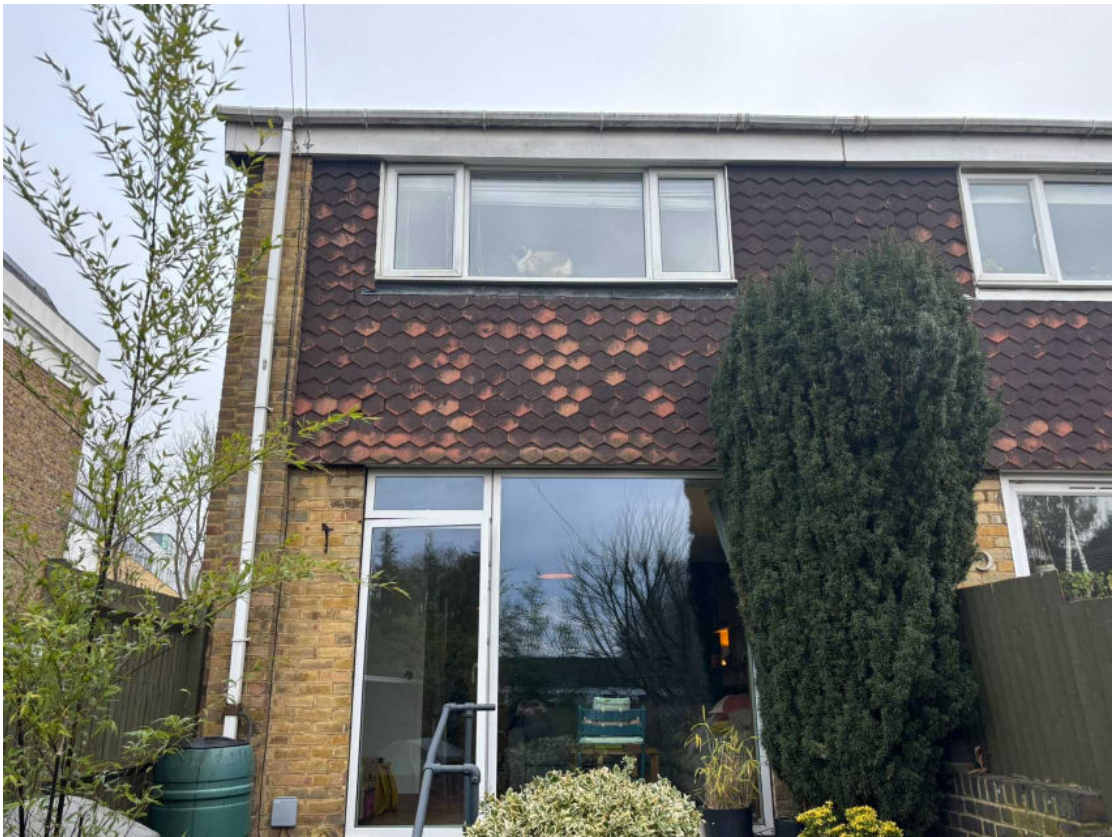
The guttering, downpipes, and gullies are overall in good order. The fixings are secure to the fascia, and the expansion joints are adequately placed, allowing for proper movement. There are no missing or damaged sections of the guttering, and the fixings to both the fascia and brick wall are securely in place. There are no obvious signs of water staining on the façade, indicating that drainage is functioning as expected.

Some debris accumulation was noted in the gutters during the drone survey, which will need to be cleared to maintain proper drainage. The downpipes run into gullies, both of which have some debris accumulation—one at the front and one at the back of the property. These should also be cleared to ensure effective water flow and to prevent potential blockages.

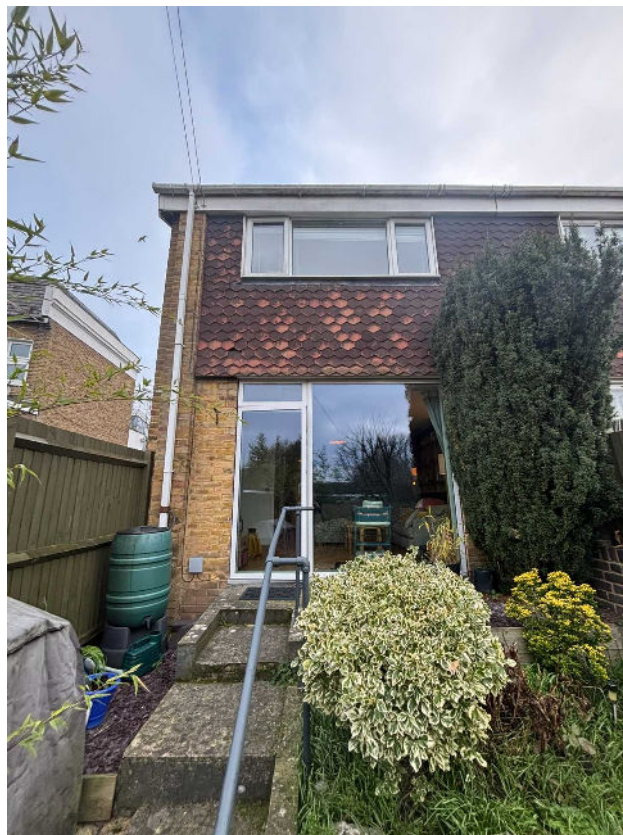
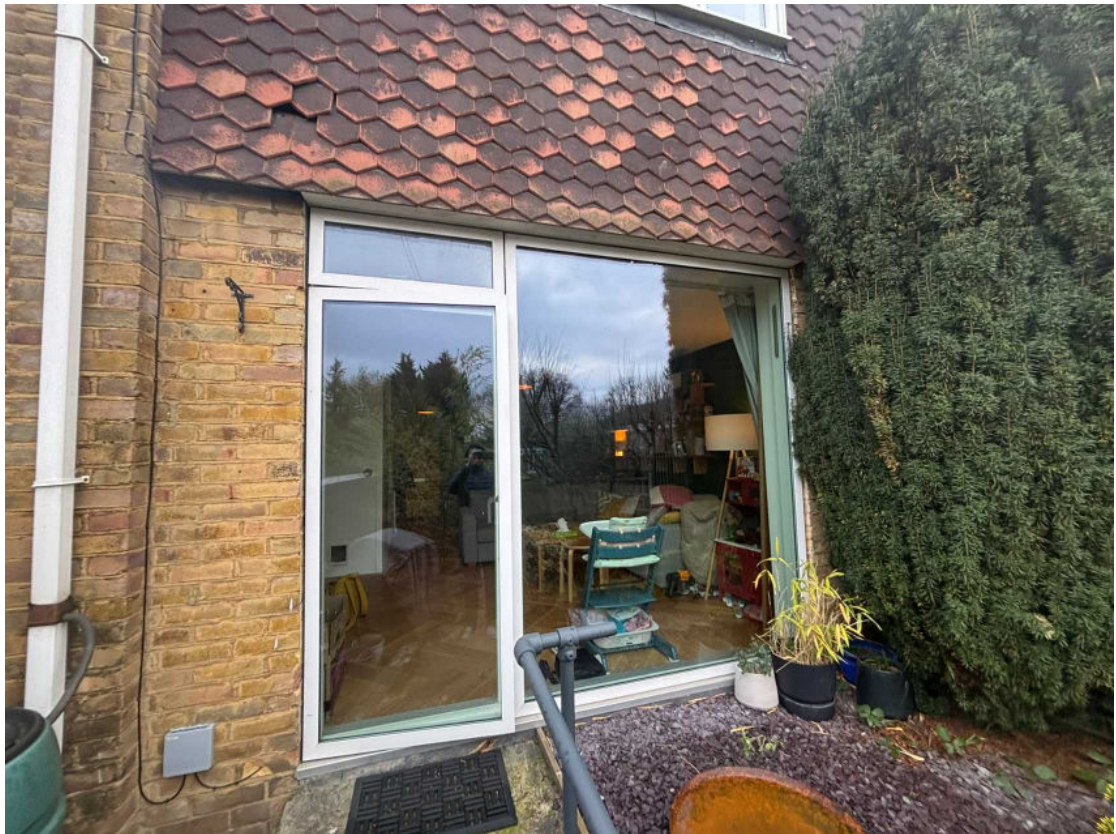
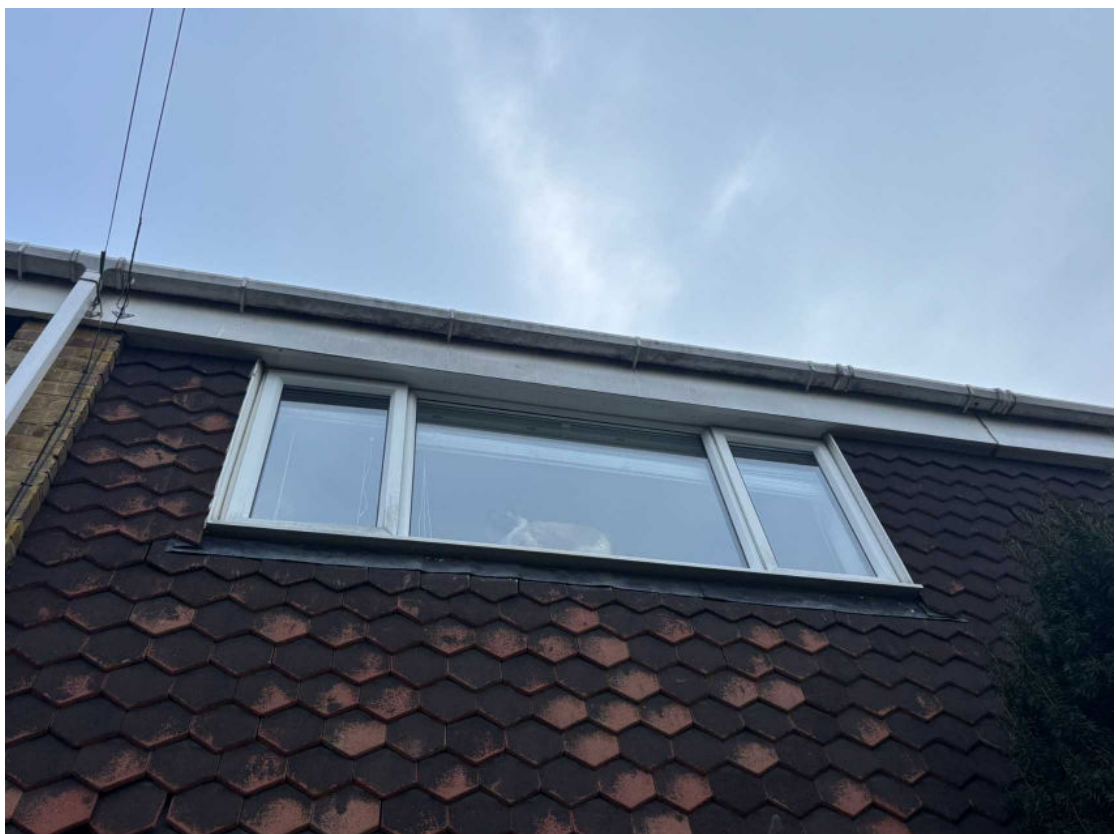
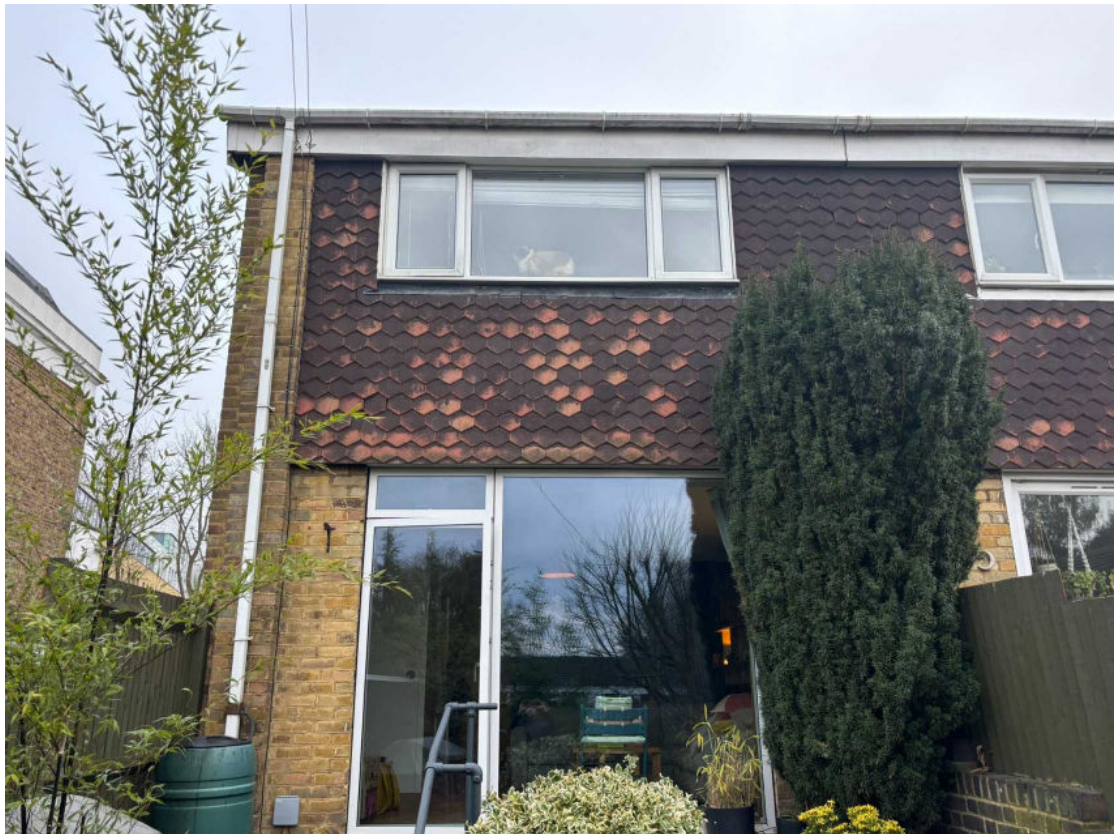
The main walls of the property consist of a mix of exposed brick and tiles. The brickwork is in good condition, with the pointing also in satisfactory order. There are no visible cracks or signs of bowing in the walls that would suggest subsidence, heave, or any structural movement.

The tiled sections are generally in good condition, although some weathering has caused minor staining to the tiles. One tile is missing from the rear of the property. While this does not appear to have had a detrimental effect on the structure, it will need to be replaced to prevent potential water ingress and further damage.

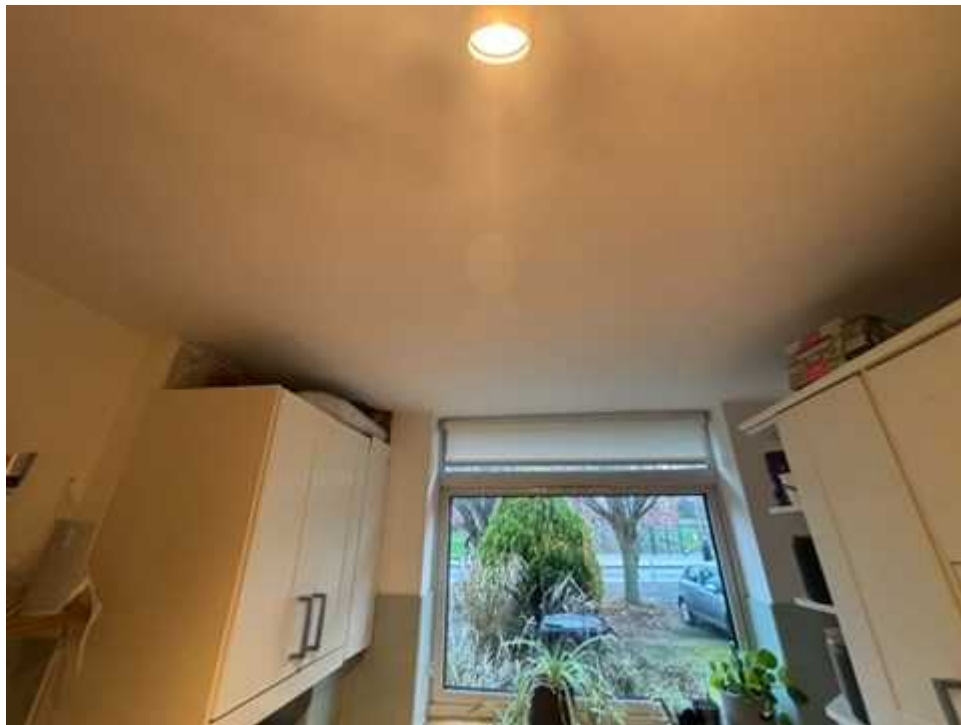
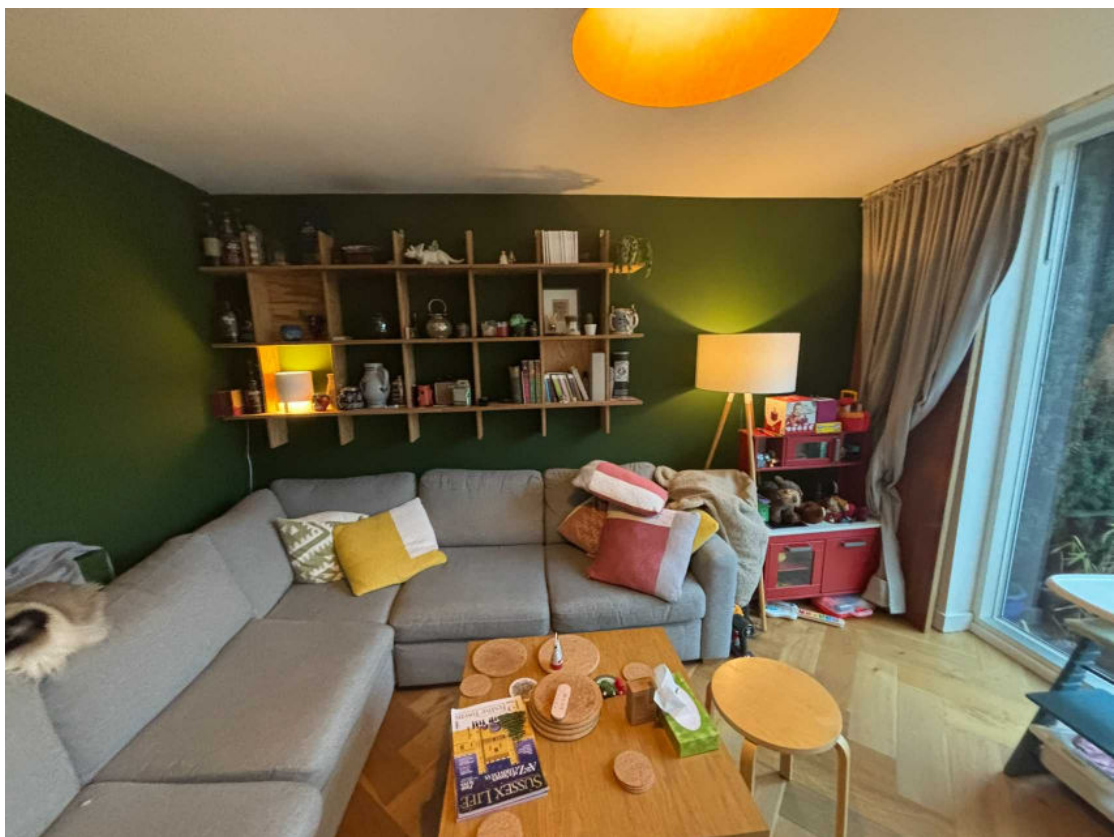
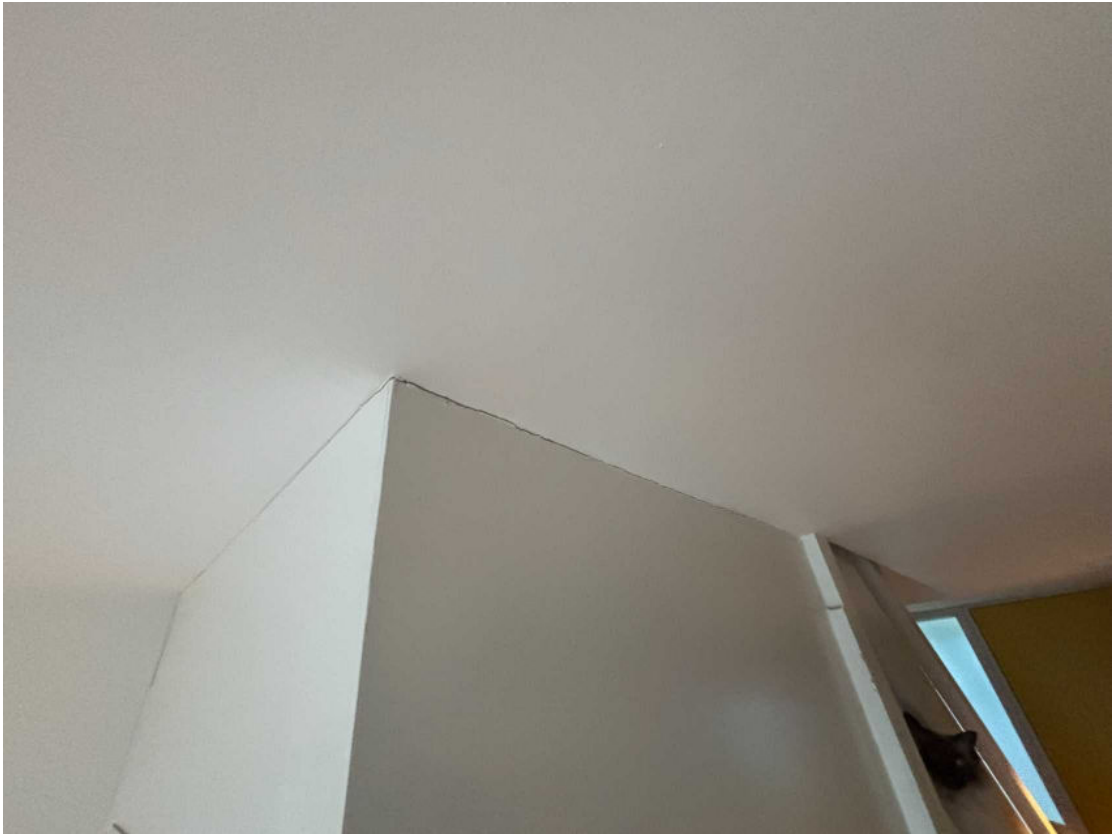
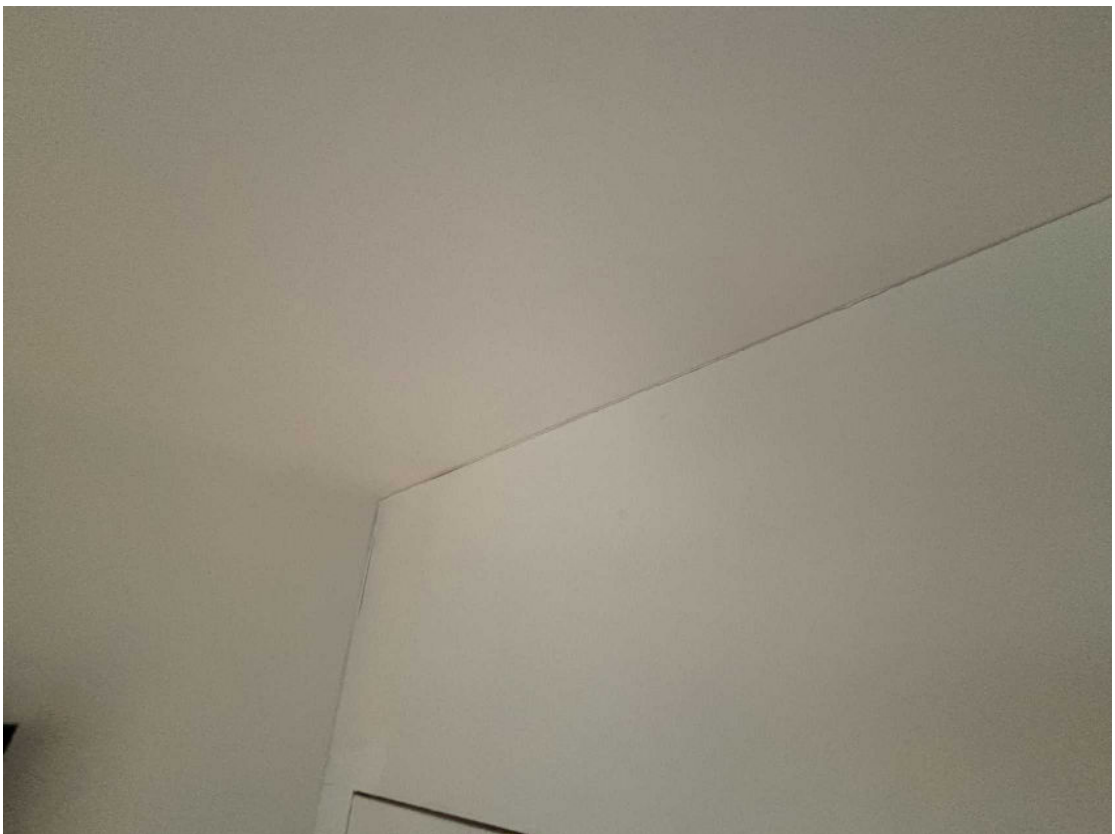
## E2 Ceilings

The ceilings throughout the property appear straight and level, with no significant signs of distortion or sagging. There are some minor hairline cracks in places, which are common in many properties and can easily be filled and redecorated to restore the smooth finish. These small imperfections do not indicate any underlying structural issues.

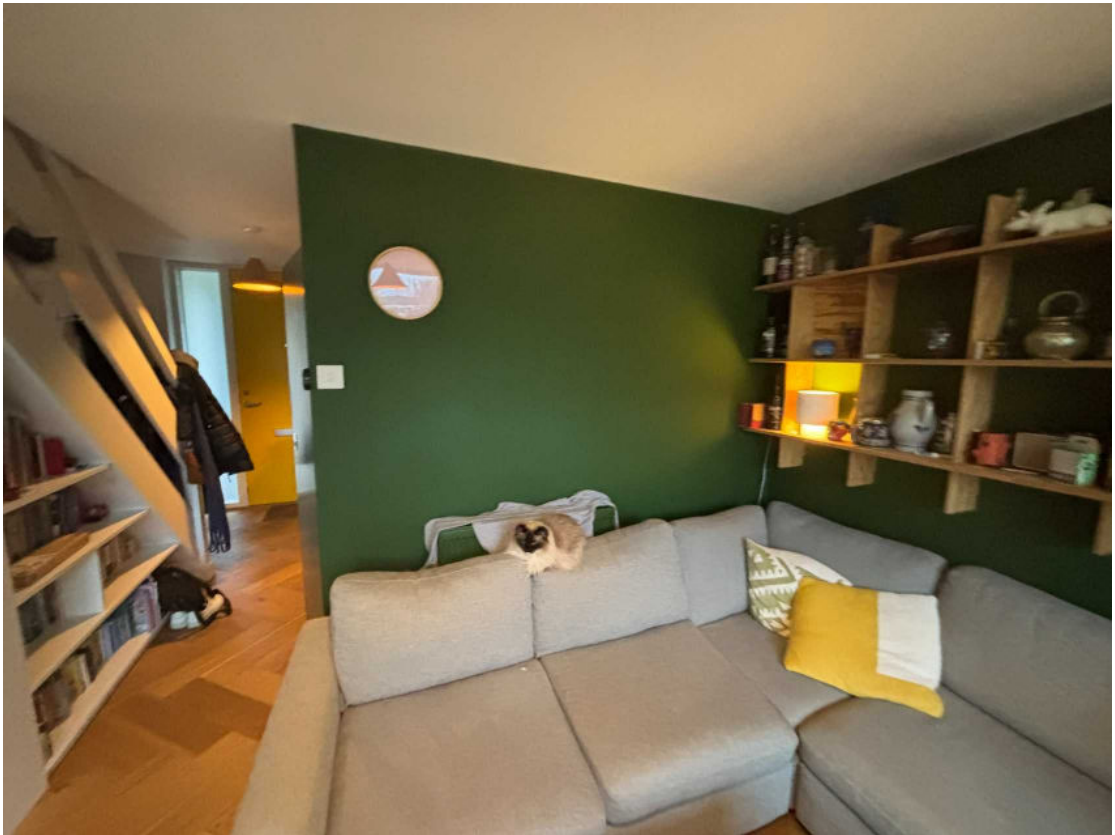
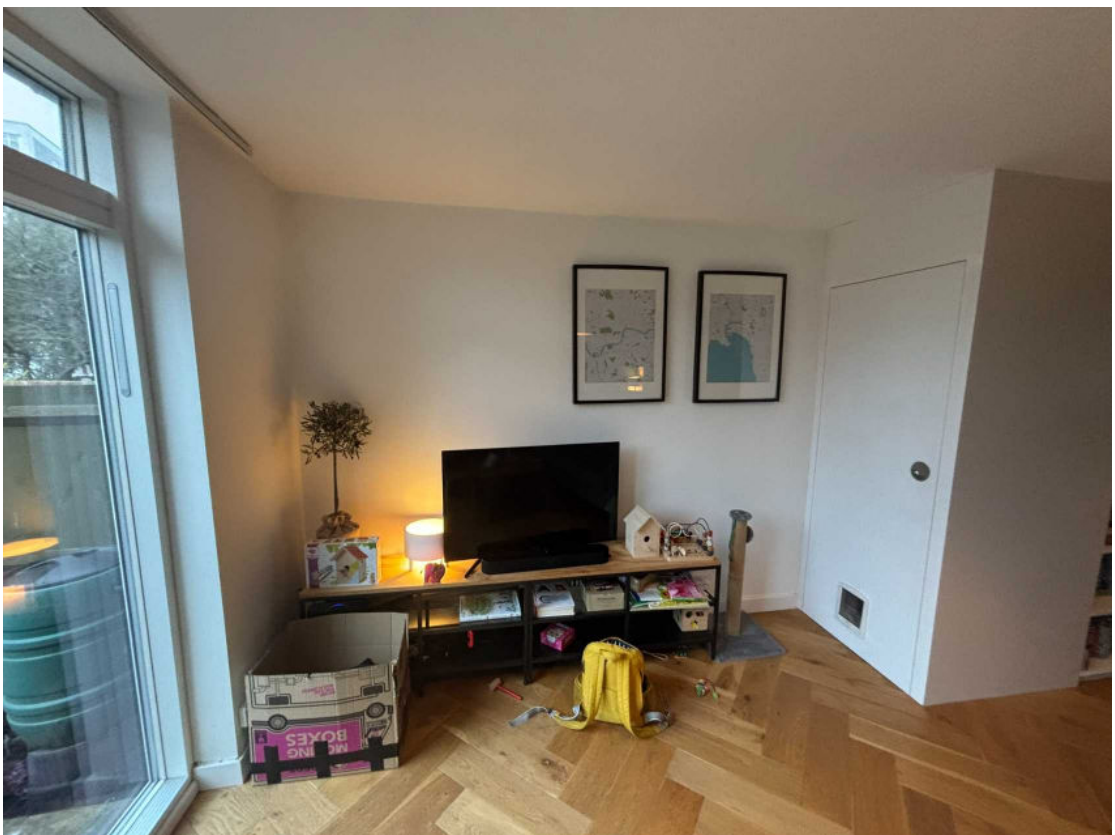
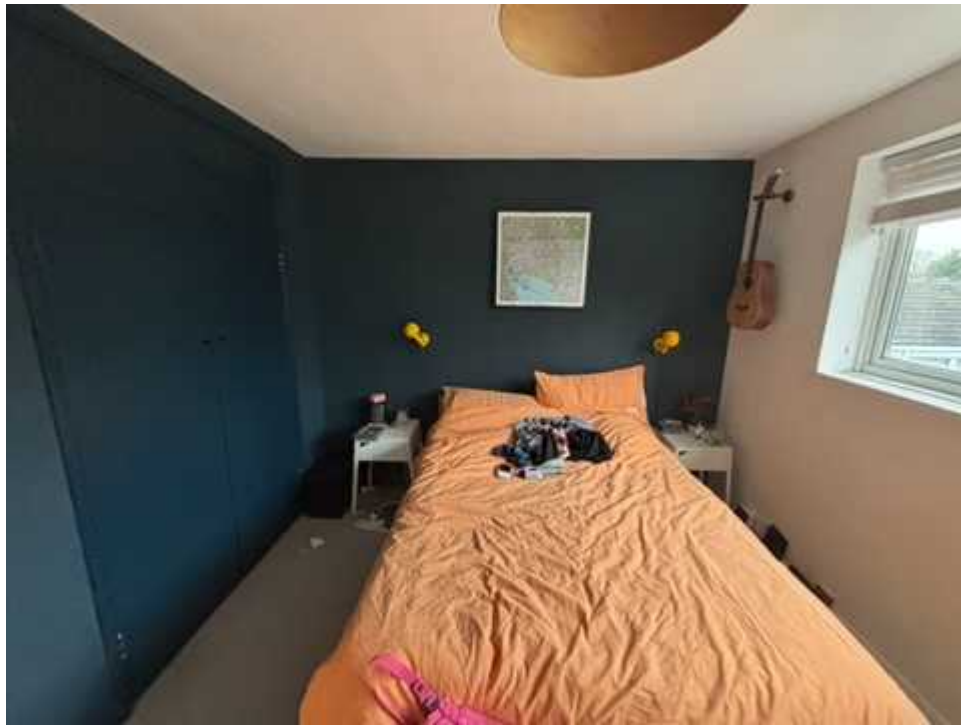
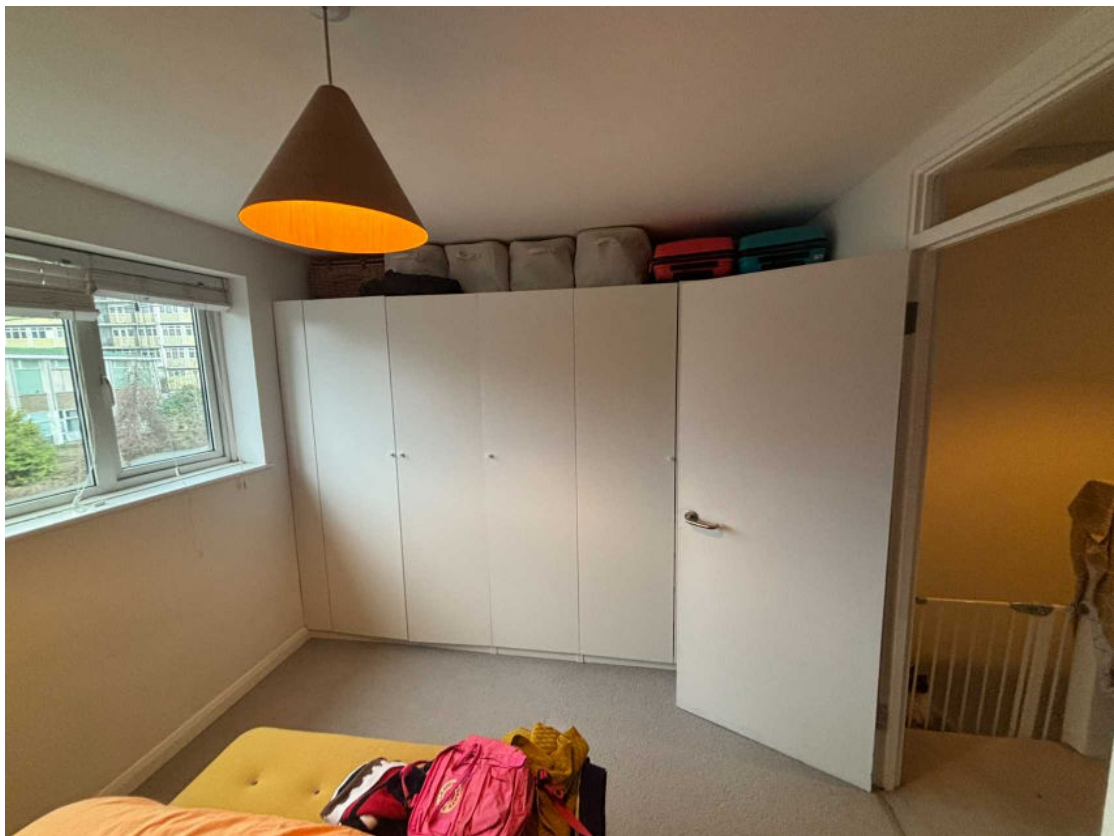
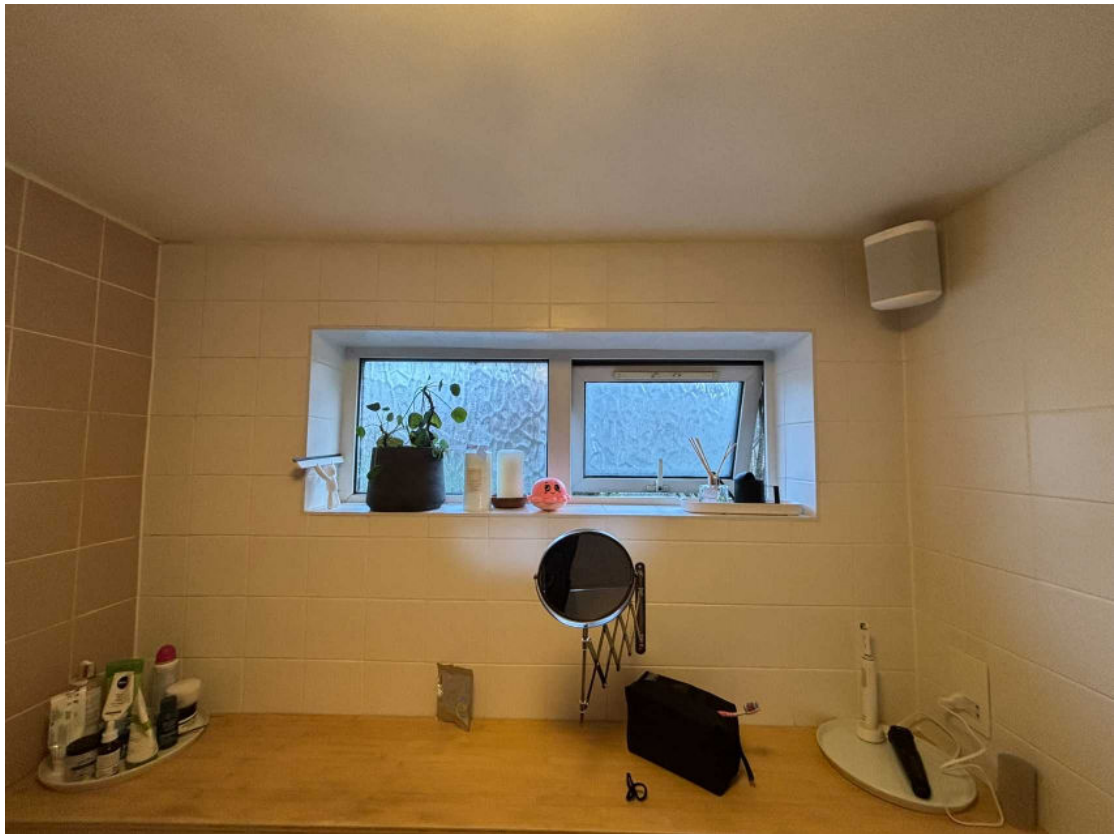
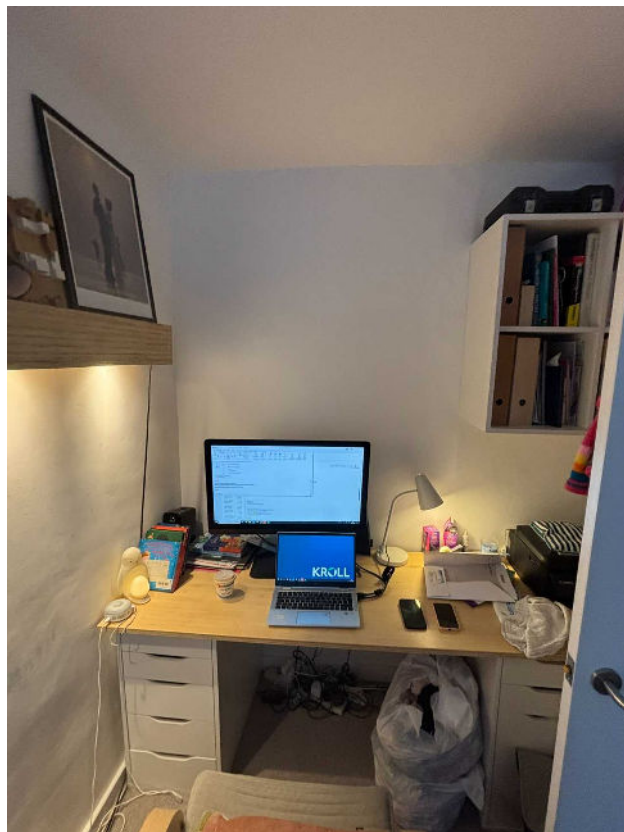
The walls are generally in good condition, with only minor hairline cracks in some areas. These are common in many properties and are cosmetic in nature, requiring only filling and decorating to restore the smooth surface. There are no damp patches evident that would suggest leaks from services, such as plumbing, or from the roof system. Additionally, there are no signs of rising damp, indicating that the damp proof course (DPC) is performing effectively.

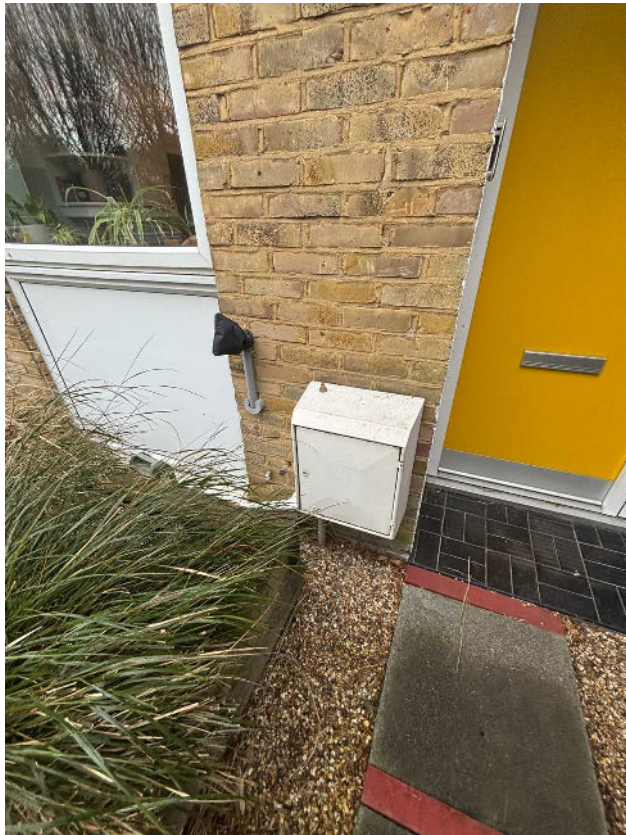
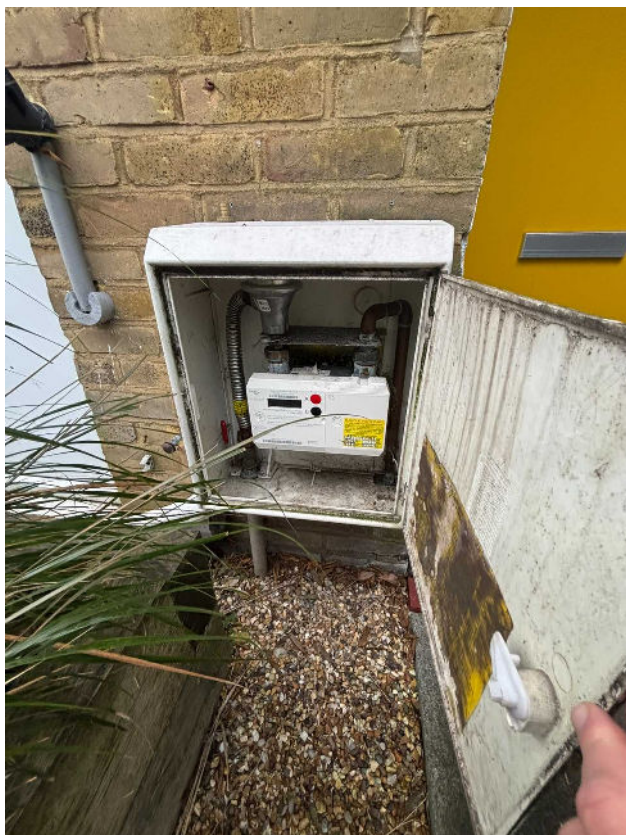
## F2 Gas/oil

The gas meter is located outside the property, secured to the external wall in a meter box. The box is in generally good condition, providing adequate protection for the meter from the elements. However, the box shows some signs of external staining and weathering, which is typical for units exposed to outdoor conditions. The gas meter itself appears to be securely installed and accessible for reading and maintenance.

It is important that the gas meter is regularly checked, and the meter box should be kept closed and securely latched to protect the meter from debris, moisture, or potential tampering. While there are no immediate concerns noted, it is always advisable to ensure that the gas meter and its connections are regularly inspected for safety by a Gas Safe engineer.

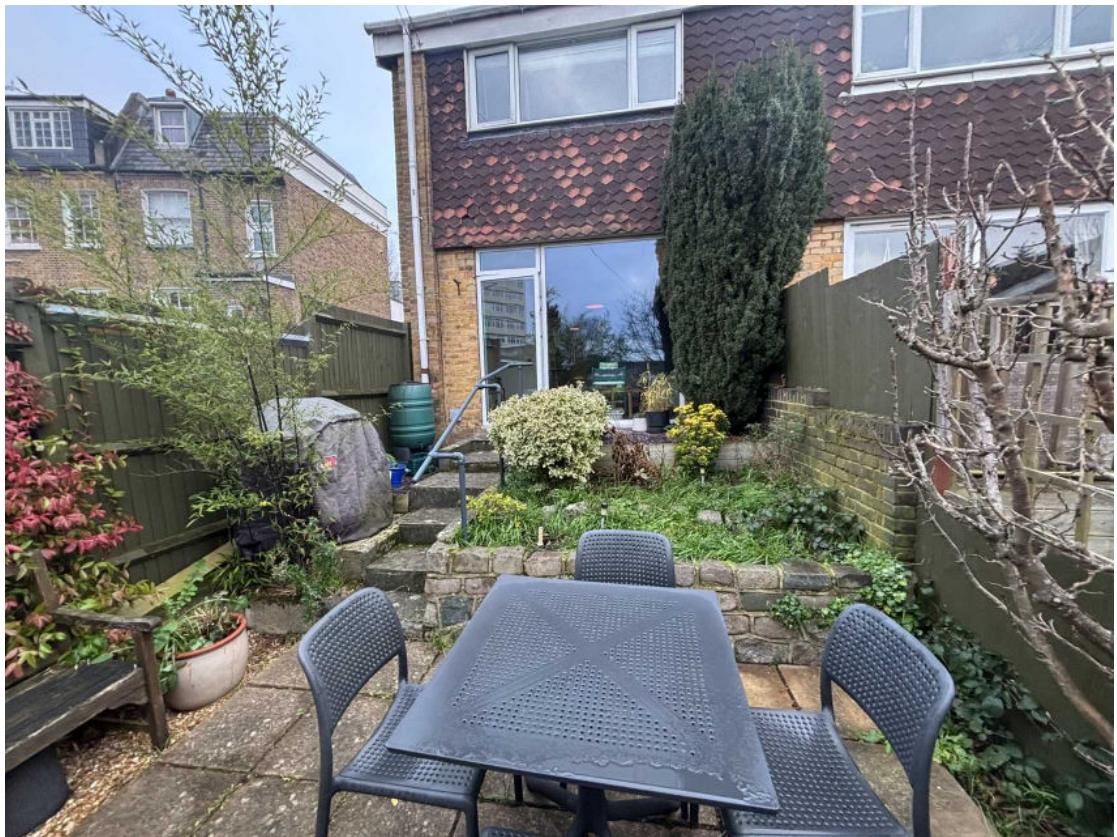
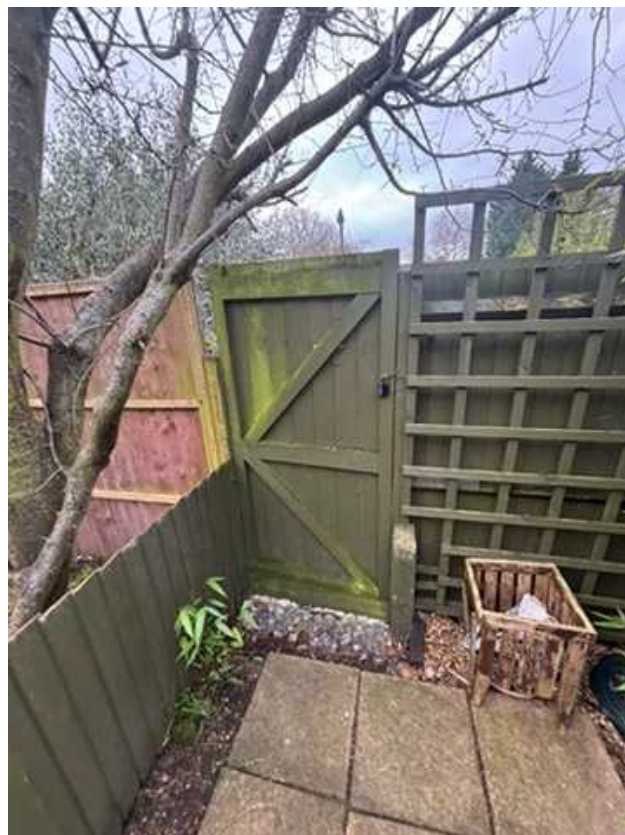
Overall, while the tree is not currently causing issues, it is wise to remain vigilant to avoid potential future complications. Regular maintenance of the tree and the structure of the house will help mitigate any risks.

- **Regular Monitoring:** It is recommended that the tree be monitored regularly, especially as it matures, to ensure that its growth does not start to affect the house. If the tree shows signs of being too close to the property, its growth can be managed, or it may need to be pruned or even removed to mitigate any potential risks in the future.
- **Tree Inspection:** Consider consulting with an arborist or tree specialist who can assess the tree's proximity to the house and provide advice on whether any action is required.
