# Your survey report

160 Dartmath Road, London, United  
Kingdom, SE22 3LQ

21/01/2025

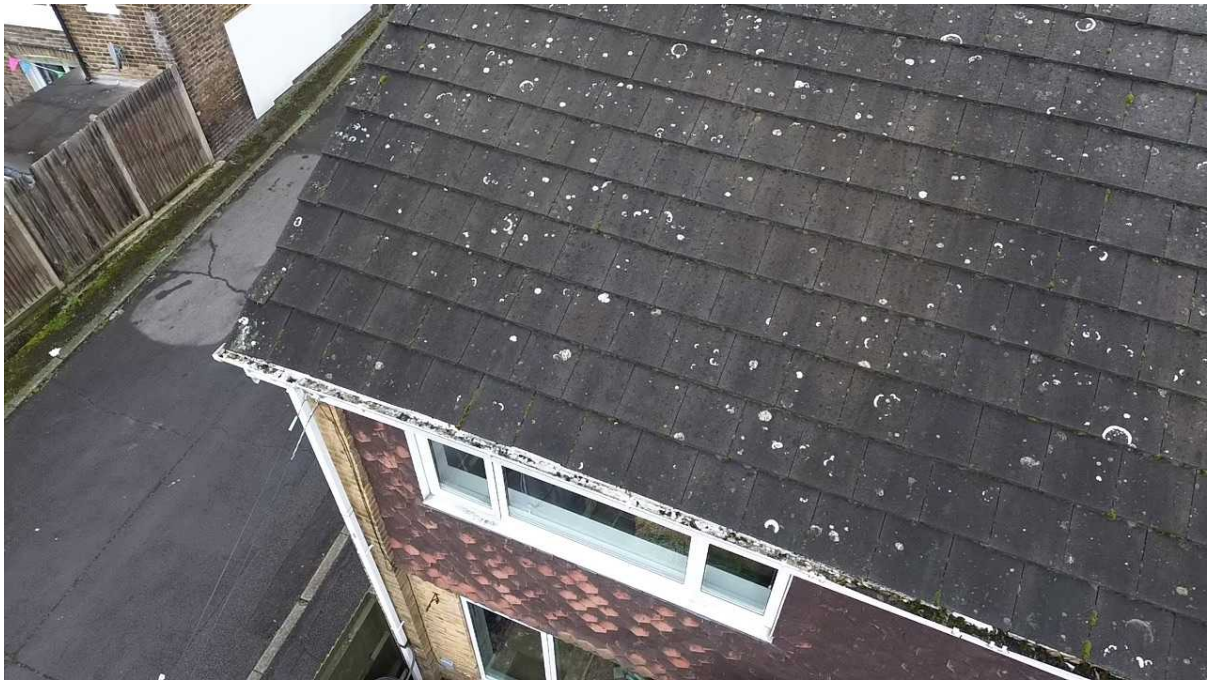
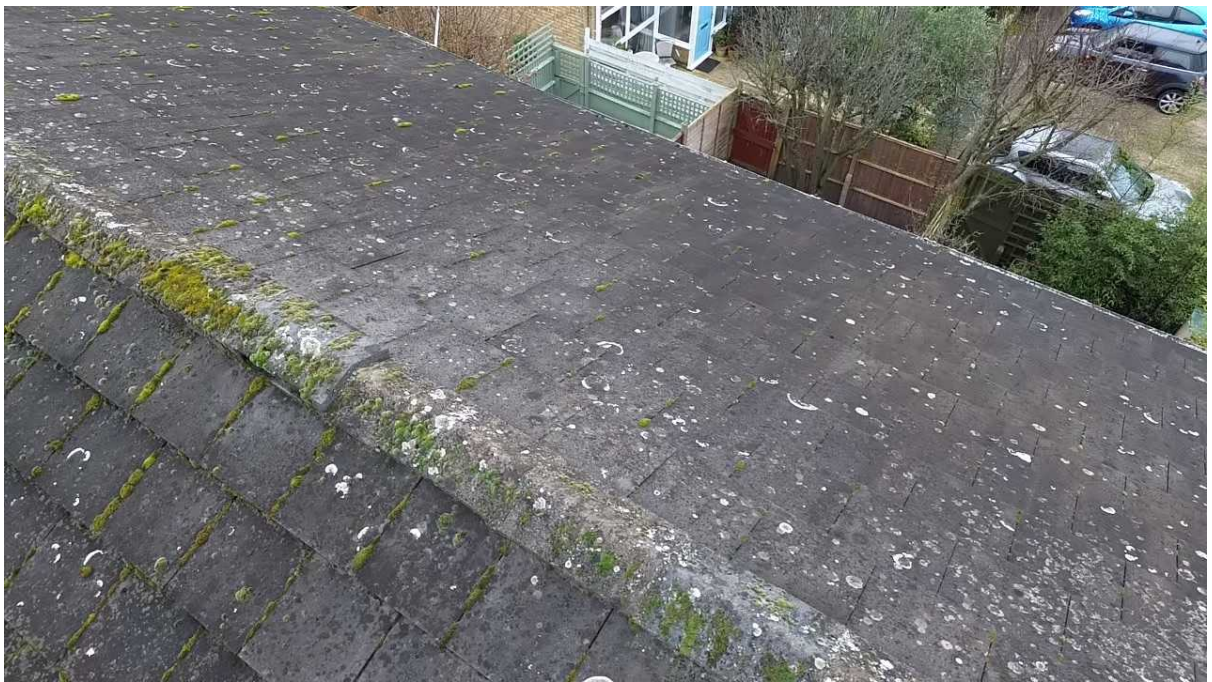
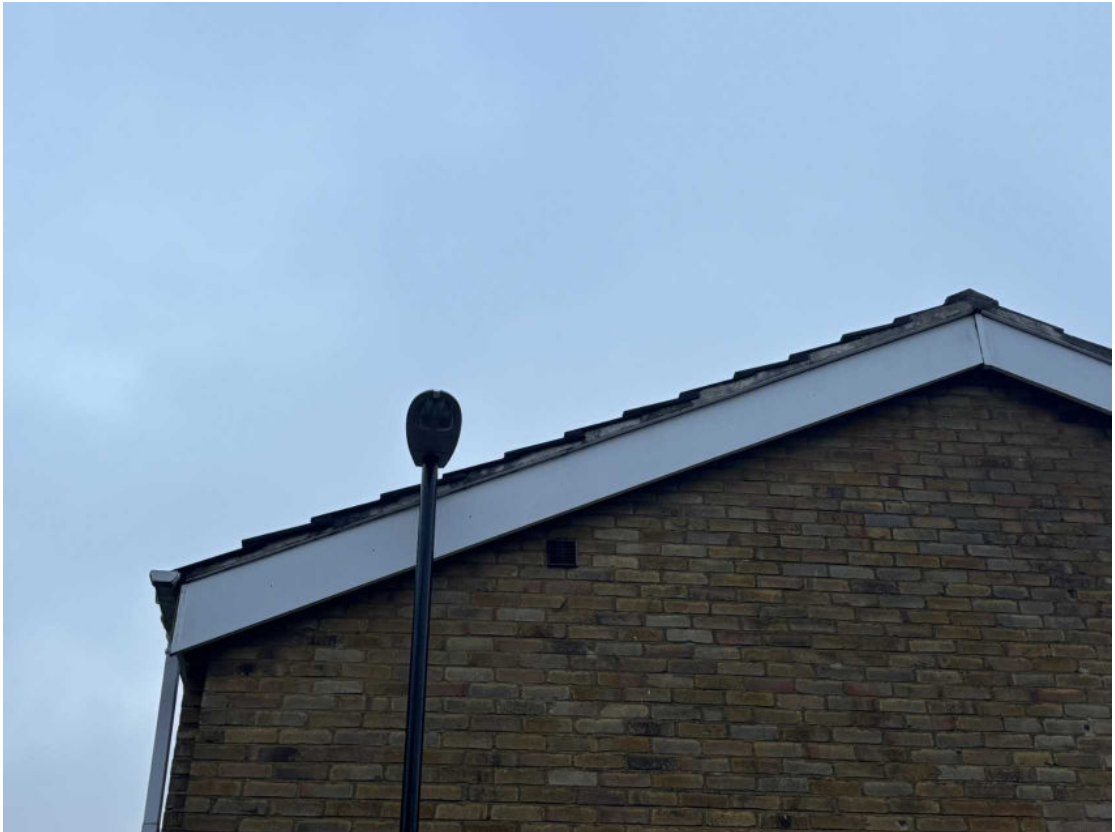
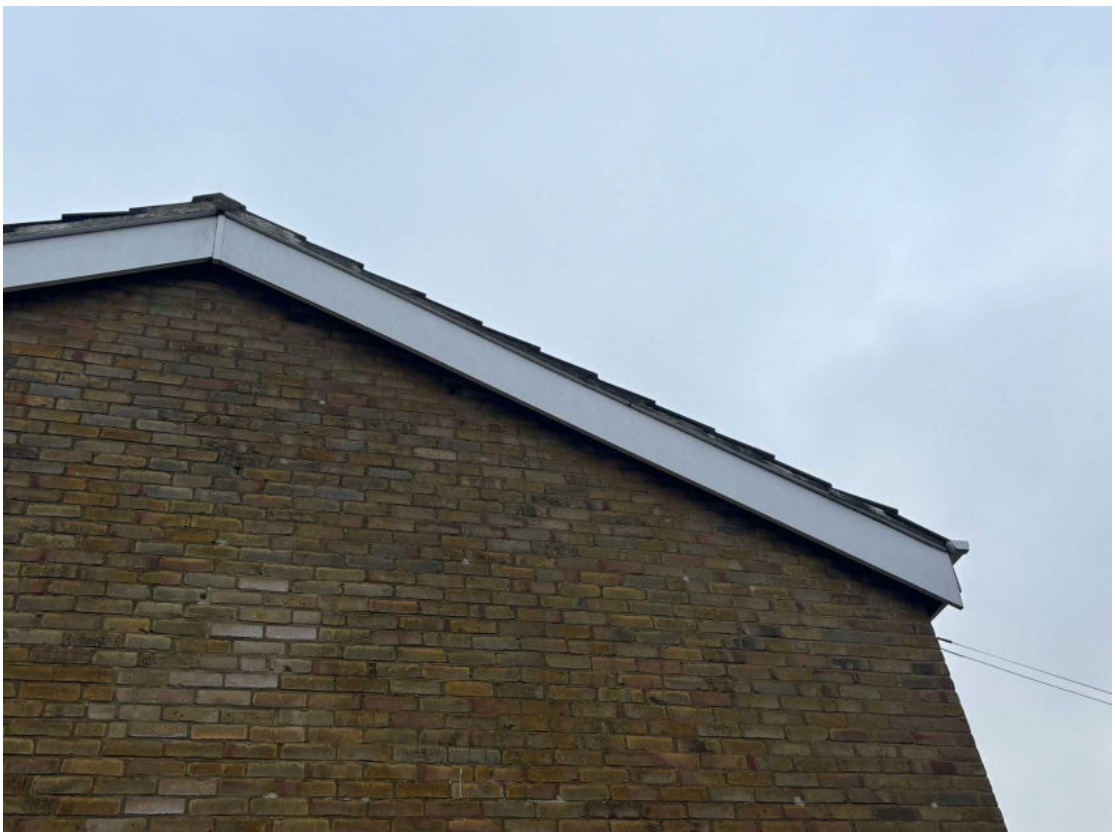
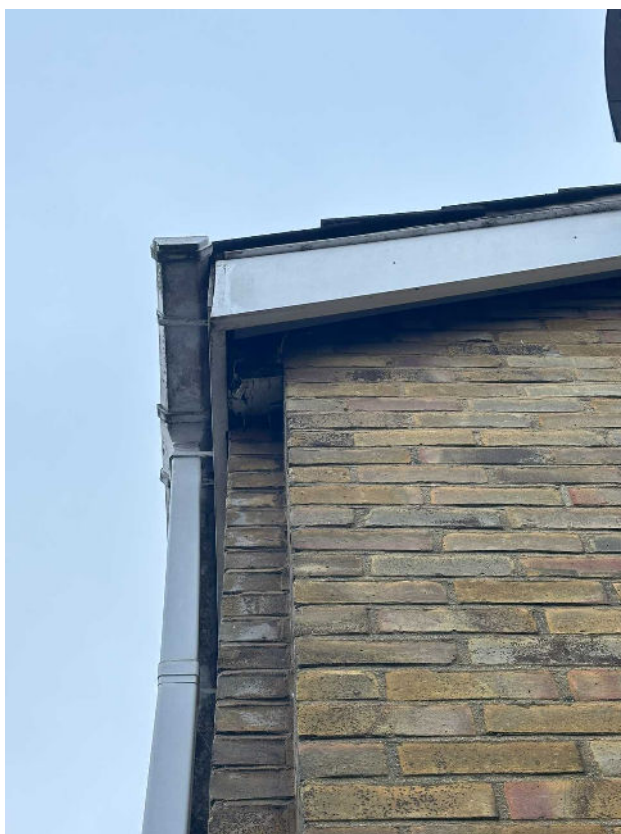
The roof is covered with concrete tiles, which appear to be in good condition overall. Moss is present on some of the tiles, which should be monitored and cleared to prevent water retention and potential damage over time. There are no missing tiles, and the ridge line remains straight with ridge tiles in good order. Ridge vents are properly installed and functioning as intended.

Overall, the roof structure appears sound with no signs of overloading or significant damage.

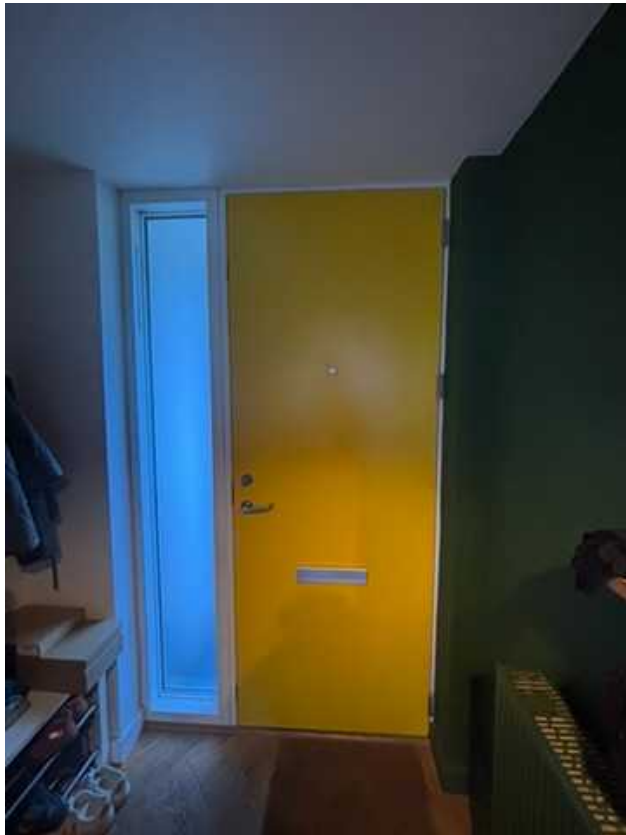
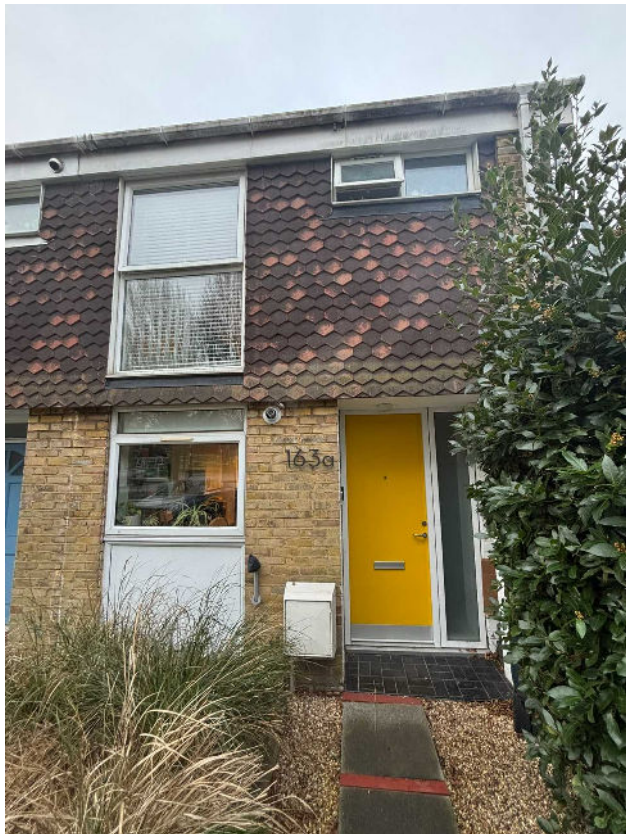
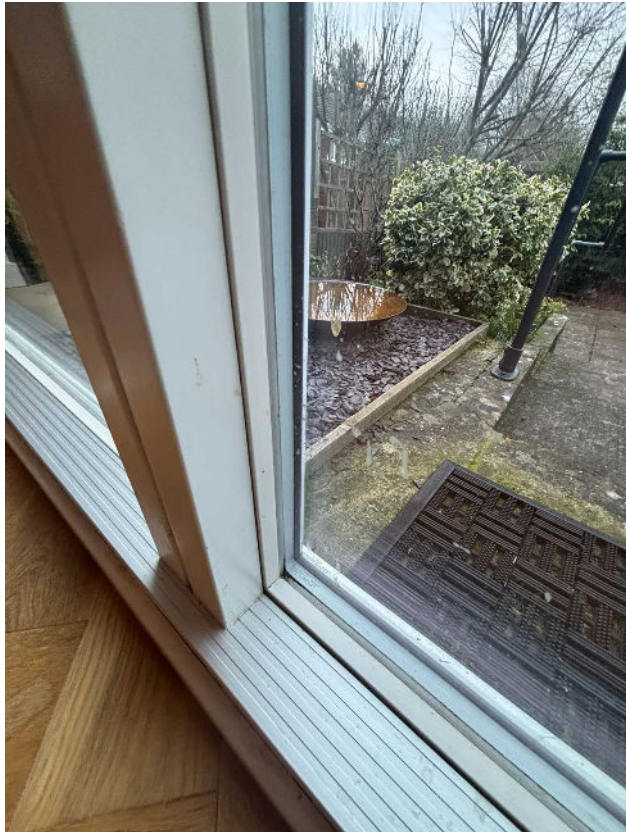
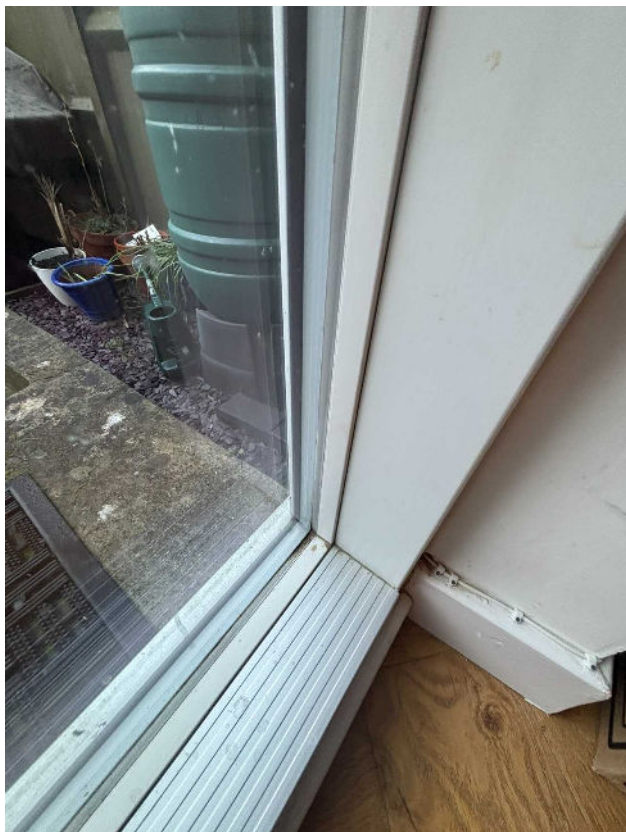
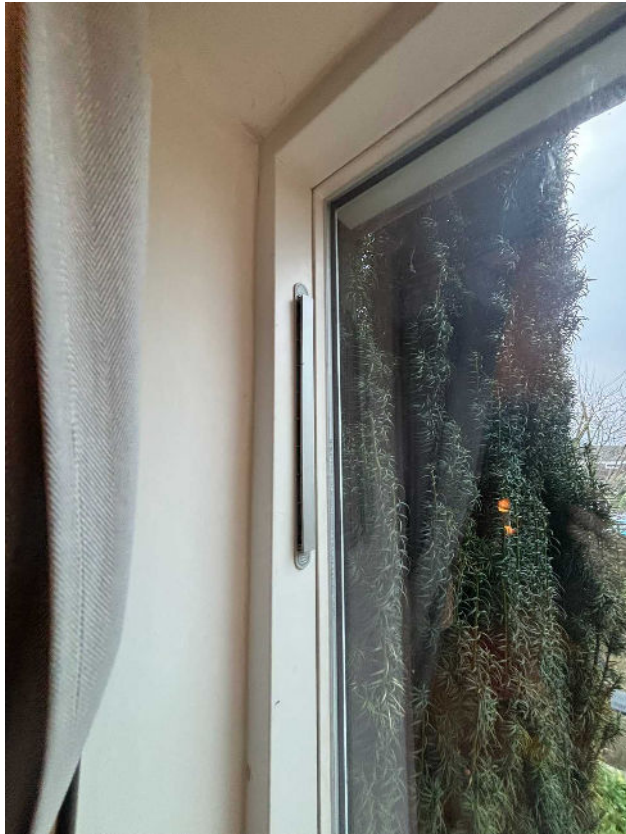
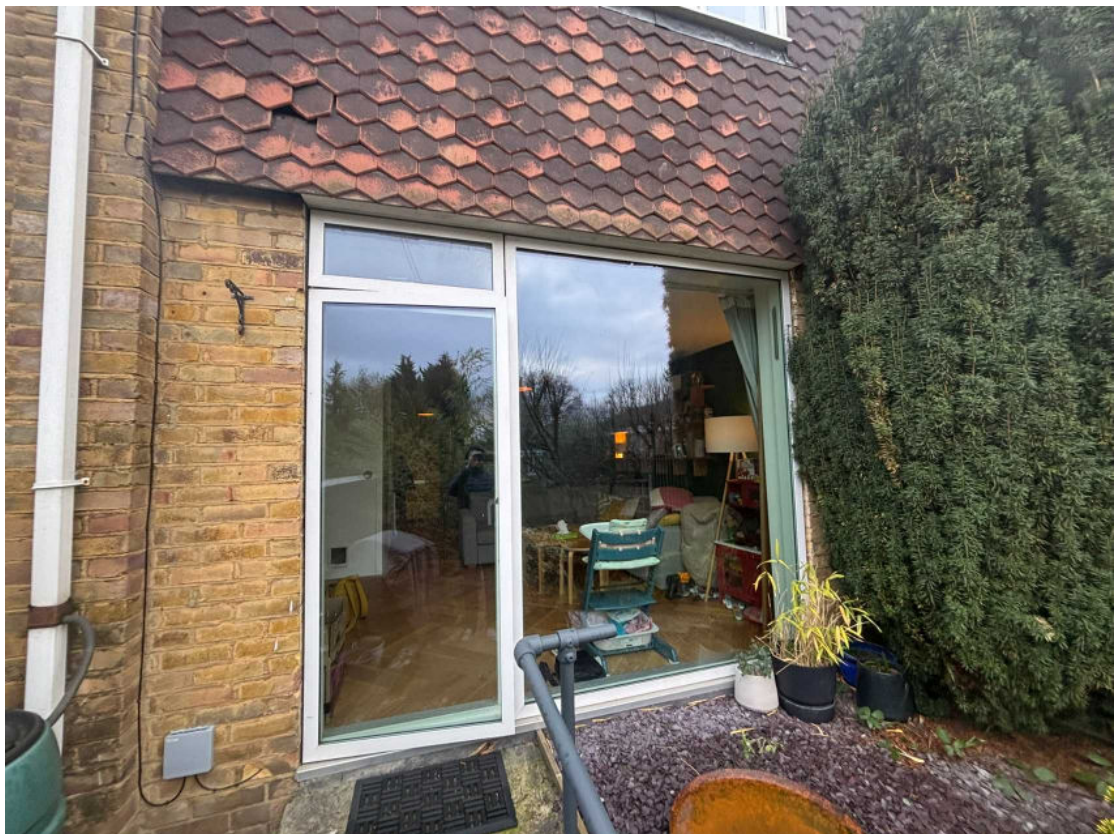
## D7 Conservatory and porches

The front door is a bright yellow timber door, which adds a distinctive feature to the property's facade. It is in good condition and fully operational. Adjacent to the door is a small, well-maintained white letterbox, and the space around it is kept clear of obstructions.

Overall, the porch area is clean, functional, and aesthetically appealing, offering a pleasant first impression of the property.

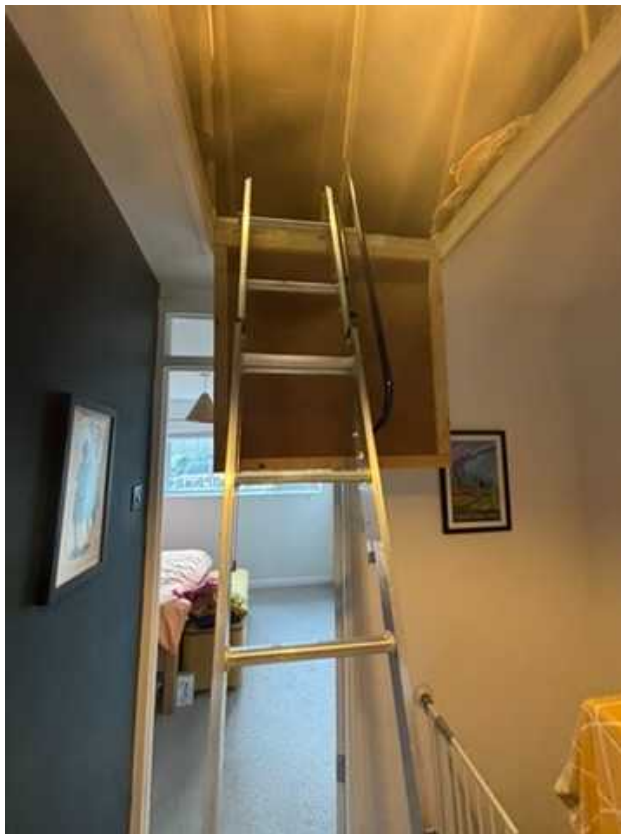
The sarking layer, which is essential for providing additional weather protection, is also in good order, showing no signs of wear or deterioration. The party wall, made of brick and block work, is suitably sealed to ensure it provides the necessary fire protection, with no gaps or areas of concern.

Additionally, there are no signs of woodworm or beetle infestation in the timber, and the timbers themselves show no signs of deflection that would indicate overloading or structural issues. This suggests that the roof structure is stable and in sound condition, with no major concerns regarding the overall integrity or load-bearing capacity.

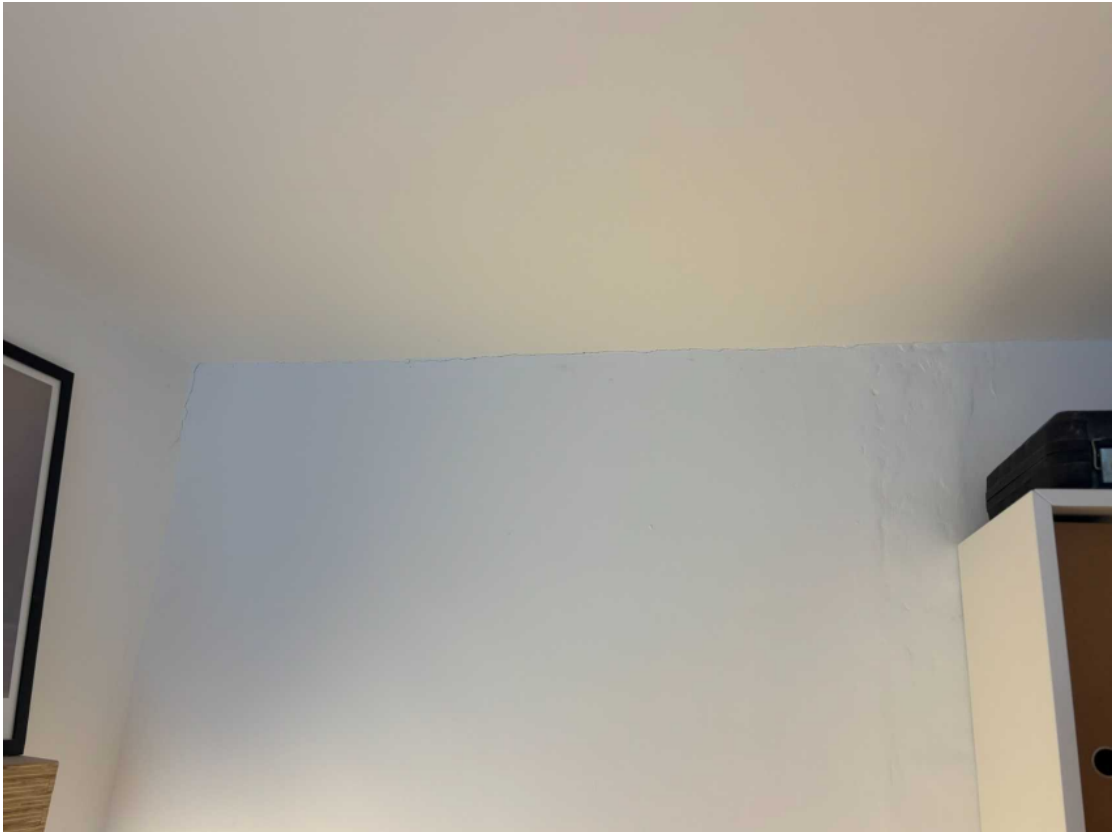
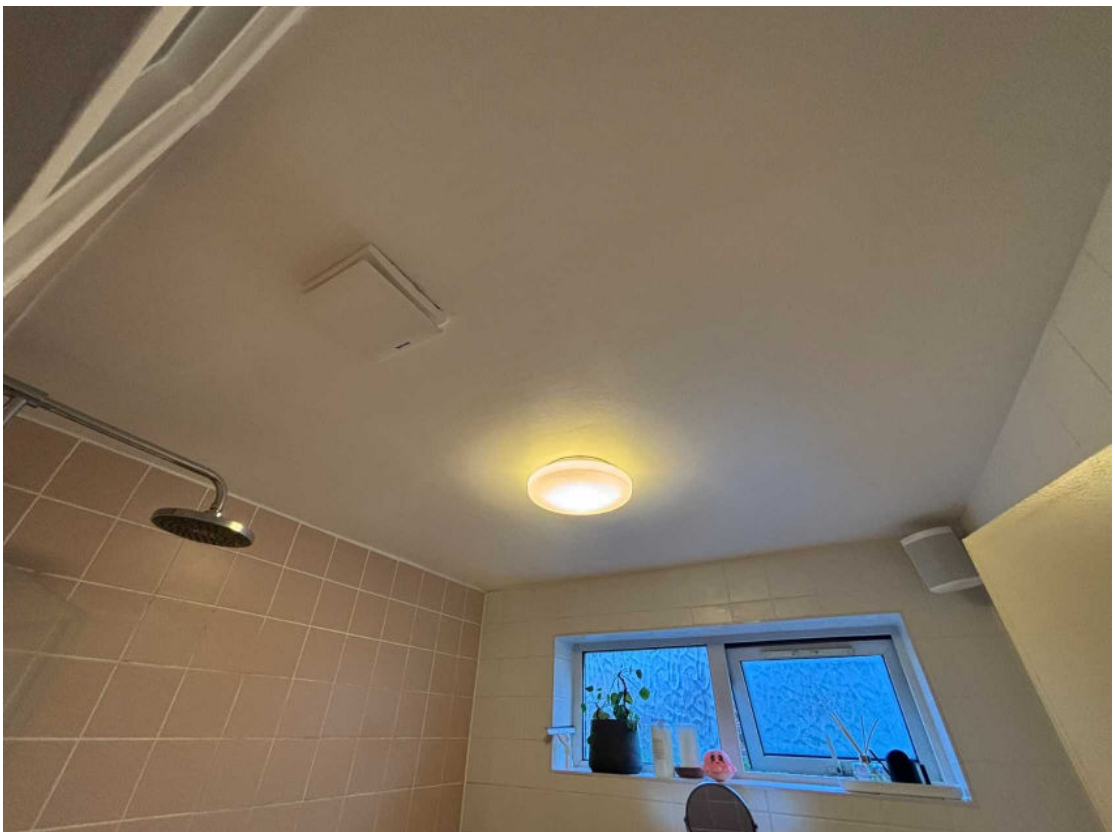
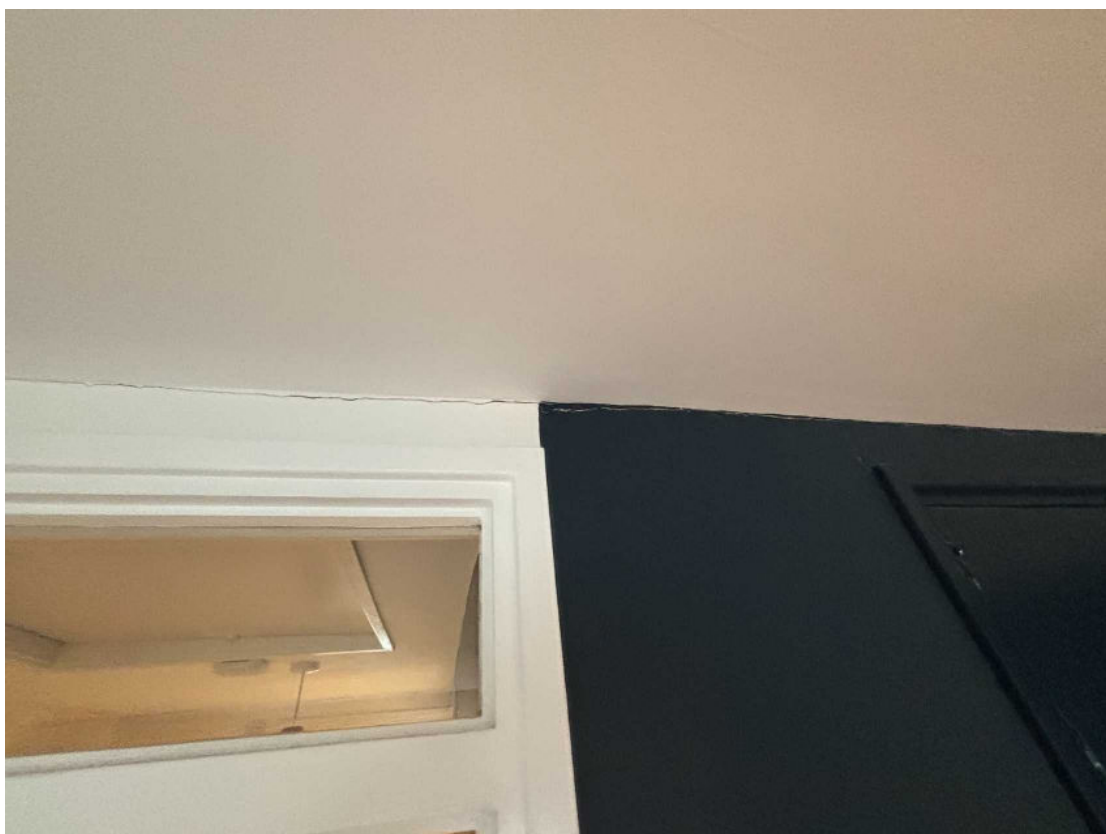
The ceilings throughout the property appear straight and level, with no significant signs of distortion or sagging. There are some minor hairline cracks in places, which are common in many properties and can easily be filled and redecorated to restore the smooth finish. These small imperfections do not indicate any underlying structural issues.

There are no signs of damp patches, which could indicate leaking pipes or issues with the roof system. This is a positive sign that the property is dry and that the plumbing and roofing systems are functioning as they should. Overall, the ceilings are in good condition and do not require any major work beyond minor cosmetic repairs.

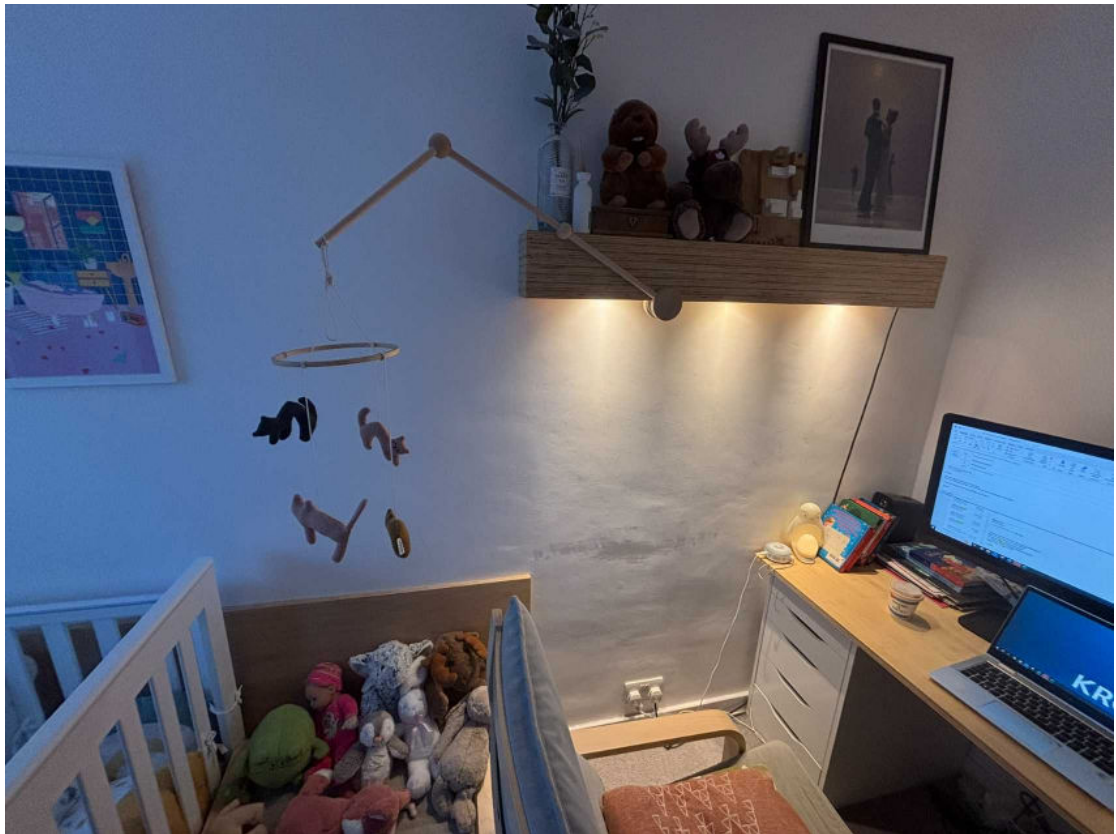
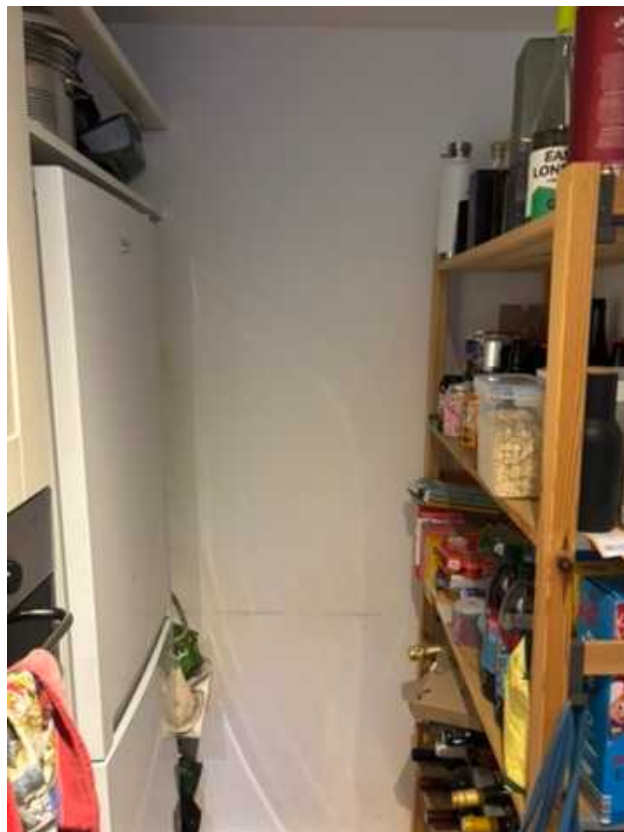
The walls are generally in good condition, with only minor hairline cracks in some areas. These are common in many properties and are cosmetic in nature, requiring only filling and decorating to restore the smooth surface. There are no damp patches evident that would suggest leaks from services, such as plumbing, or from the roof system. Additionally, there are no signs of rising damp, indicating that the damp proof course (DPC) is performing effectively.

No significant defects were observed in the walls that would suggest any structural issues, such as bowing, cracking, or settlement. The overall condition of the walls is sound, and no immediate concerns were noted regarding the building's structural integrity.

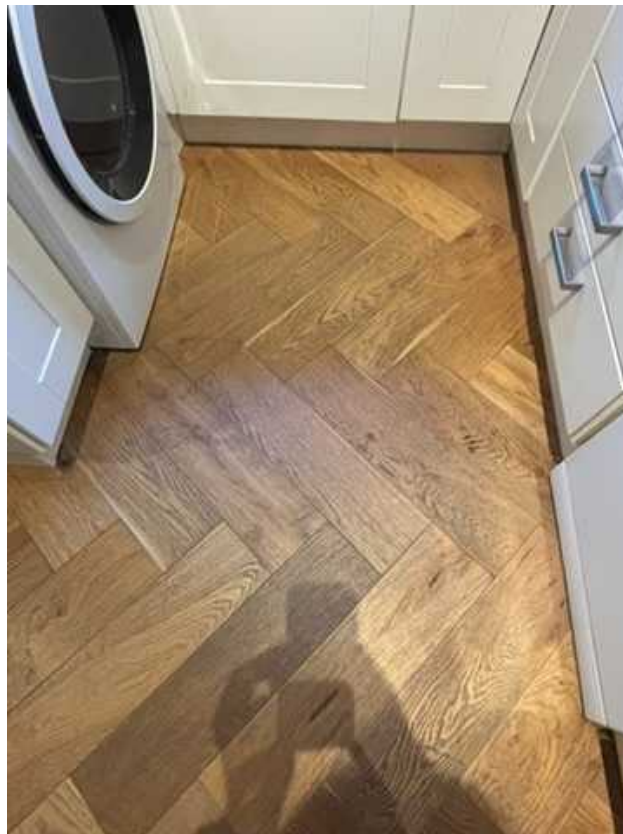
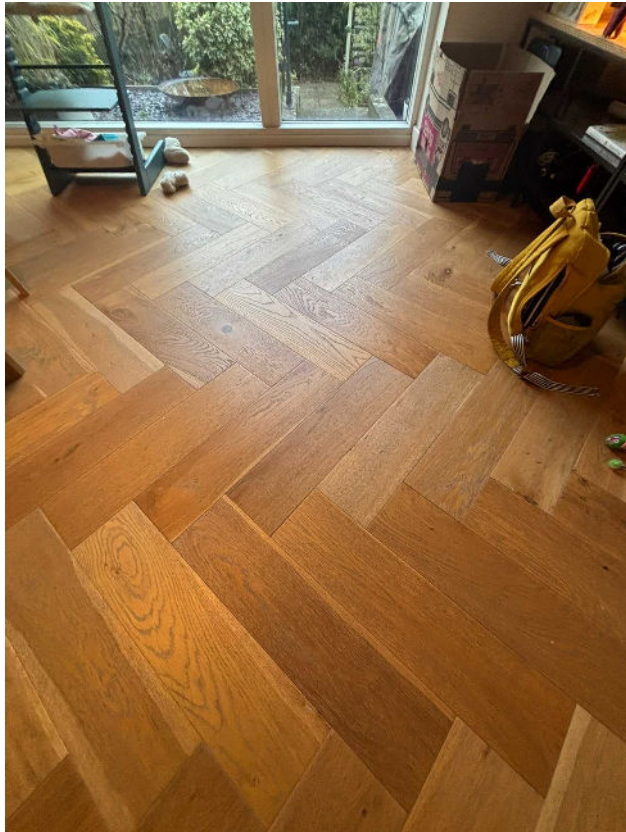
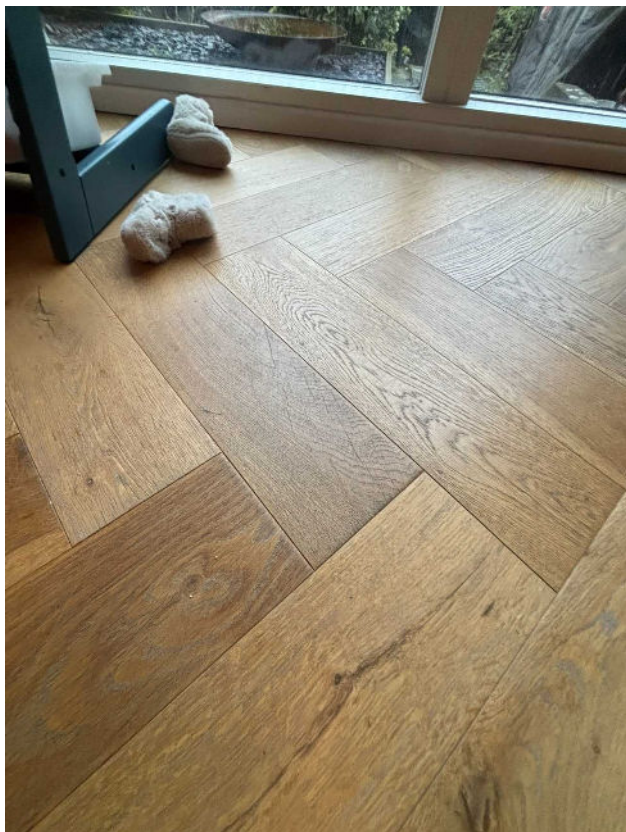
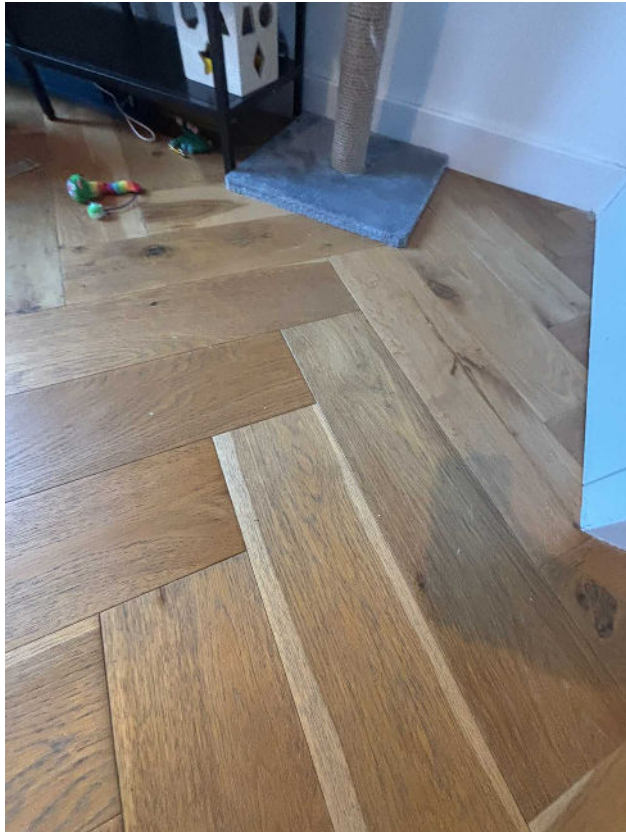
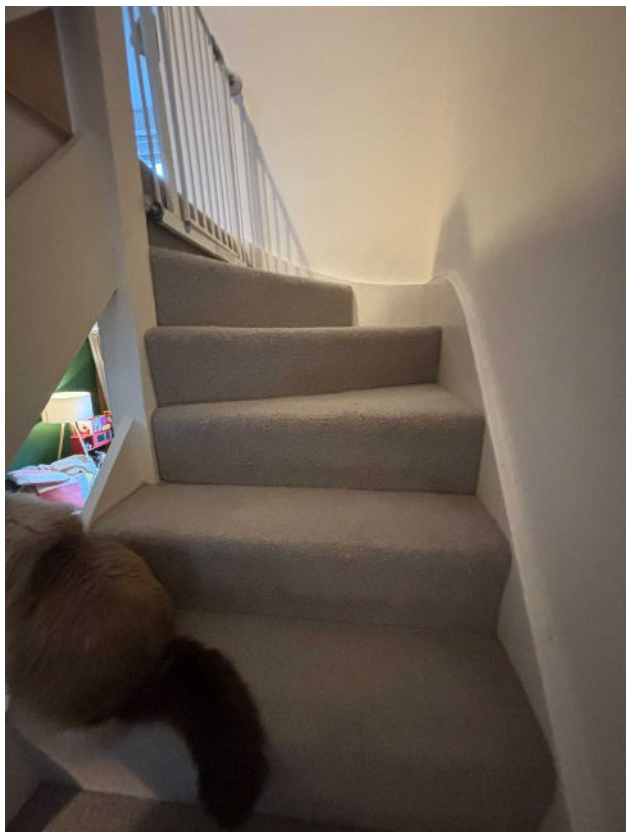
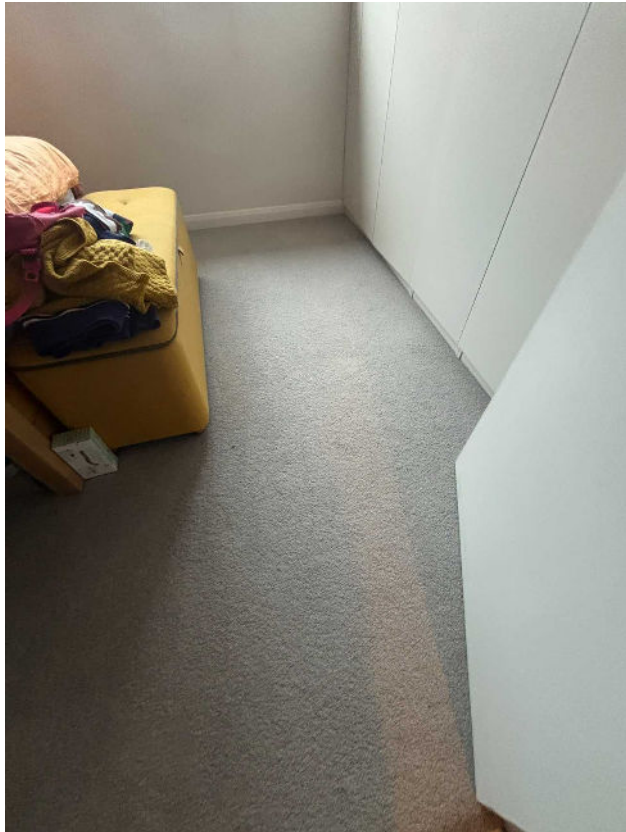
The timber flooring throughout the property appears to be in good order, with no loose or lifting areas, indicating good workmanship and stability. There are some areas of wear in high-traffic zones, which is to be expected over time. These areas may benefit from refinishing in the near future to preserve the floor's appearance and protect the timber from further wear.

The carpets in the bedrooms and on the stairs are in good condition, with no obvious marks, stains, or tears. They appear to be well-maintained, contributing to the overall comfort and aesthetic of the rooms.

The bathroom features a vinyl floor, which is in good condition with no visible defects such as bubbling or holes that would compromise its watertightness. The mastic seal around the perimeter of the vinyl flooring is intact and in good order, although it may benefit from a clean to maintain its appearance and prevent any buildup of grime.

The sub-floor system is suspected to be a suspended timber floor, which is commonly used in properties of this age. The ventilation for the sub-floor is provided by air bricks in the external wall, ensuring adequate airflow to prevent damp build-up and maintain the health of the timber structure. It is important to ensure that these air bricks are kept clear of debris and obstructions to allow for proper ventilation. Regular checks should be made to ensure they remain unobstructed, as blocked air bricks can lead to moisture accumulation under the floor, which could result in timber rot or other damp-related issues.

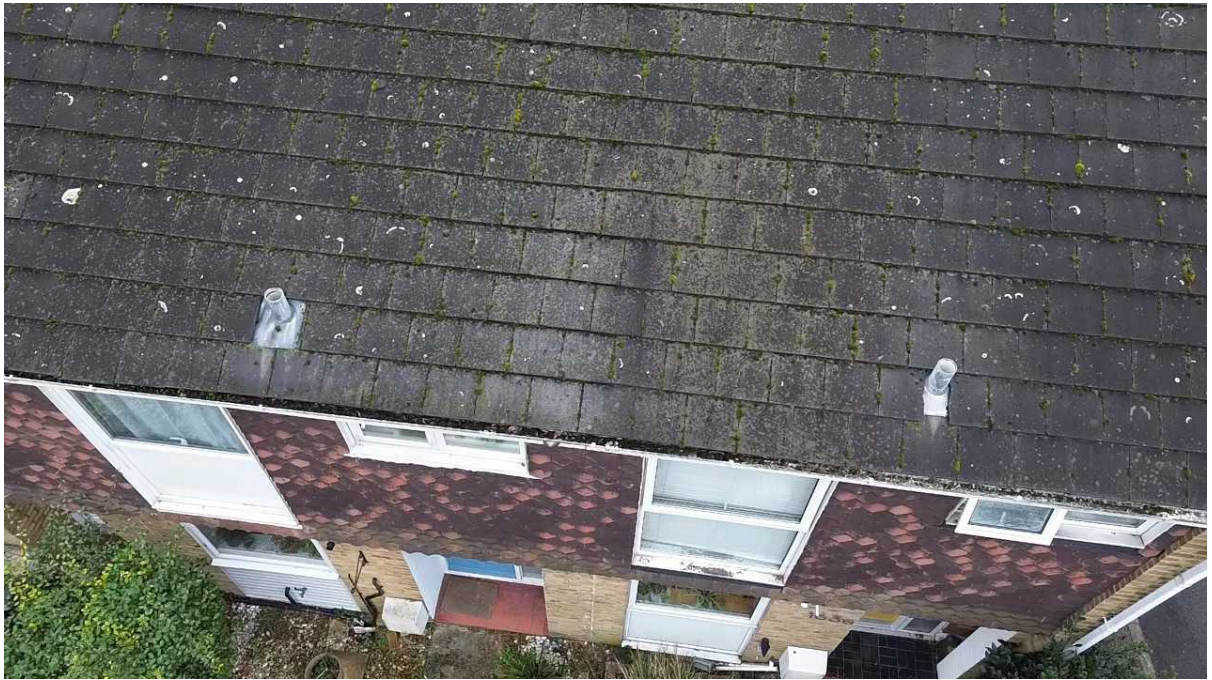
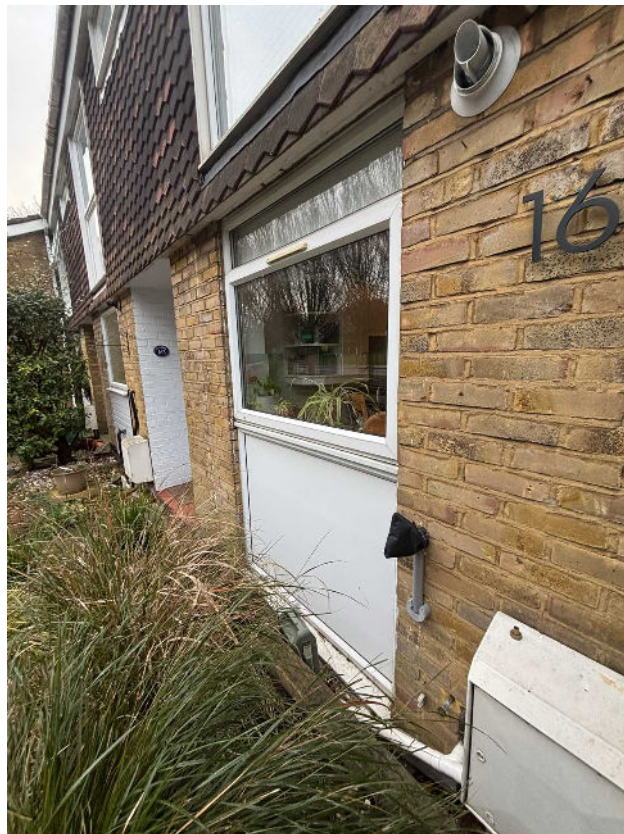
## E5 Fireplaces, chimney breasts and flues

There are no fireplaces in the property. However, there are two flues present. One flue exits from the roof and is believed to provide ventilation for the mechanical vent in the bathroom. The other flue vent exits from the kitchen and serves the boiler. Both flues appear to be in good order, with no obvious signs of blockages or damage. Proper ventilation is essential for both systems, and it is important that these flues remain clear to ensure efficient operation and prevent any potential issues with airflow or moisture buildup. Regular checks should be made to maintain their functionality.

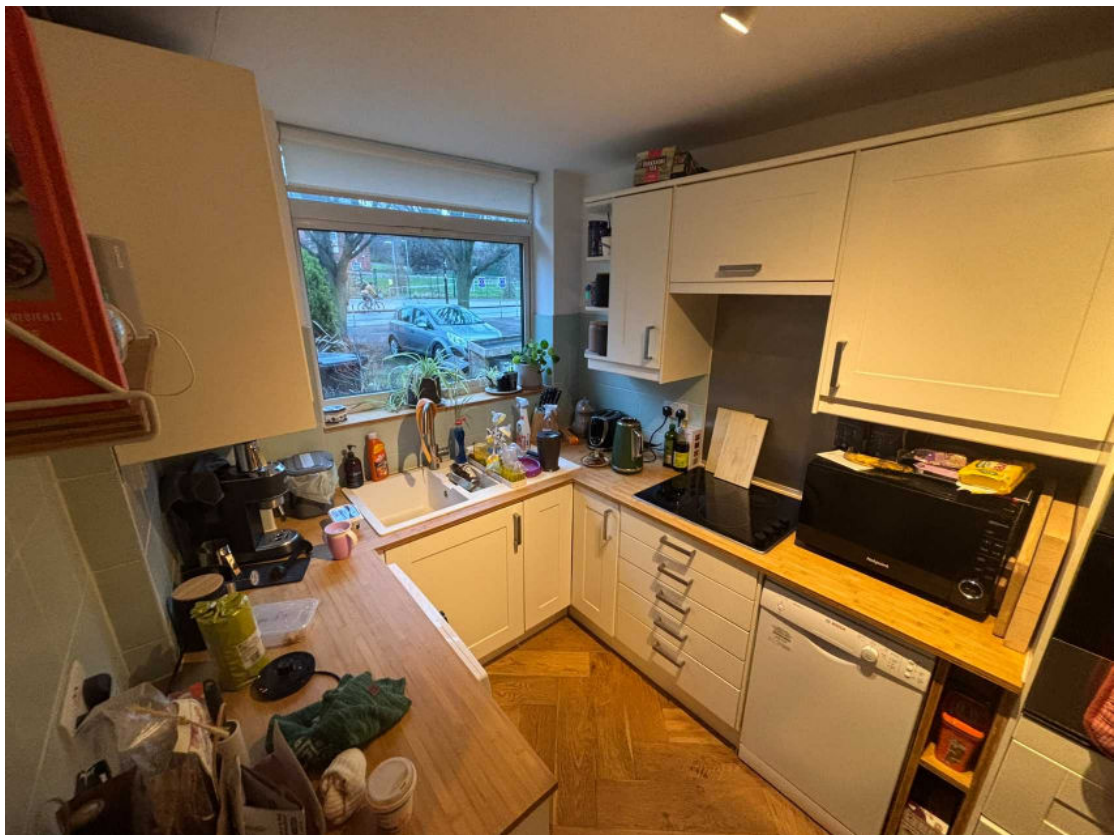
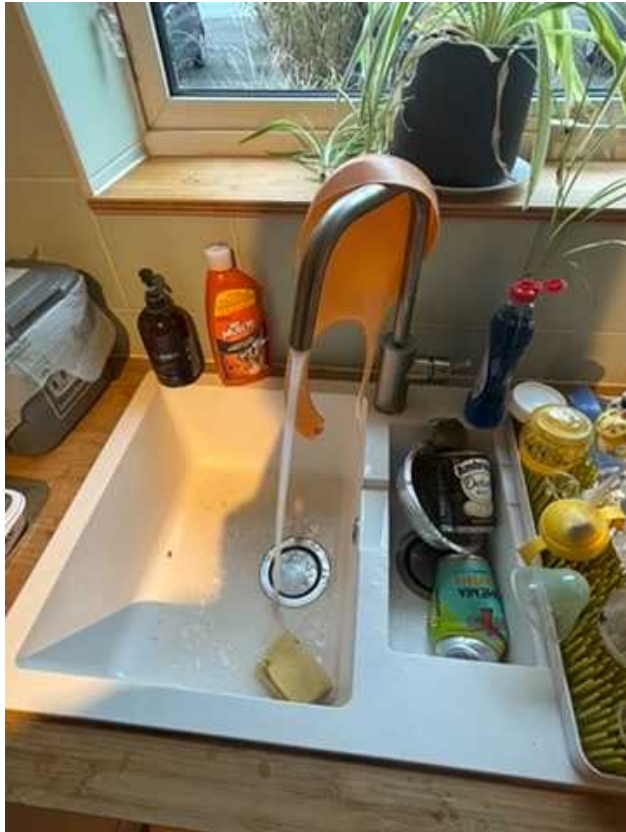
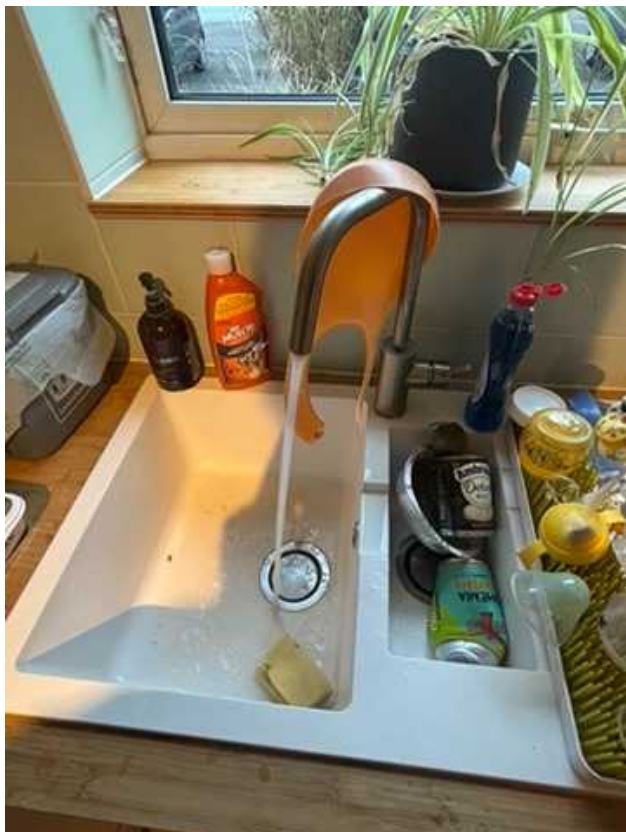
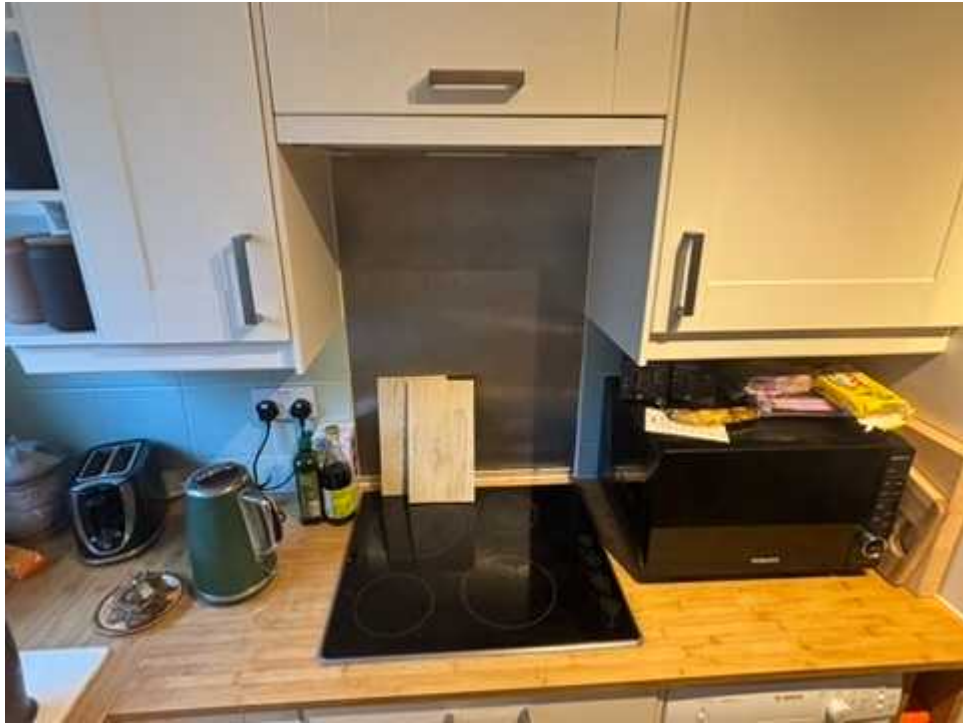
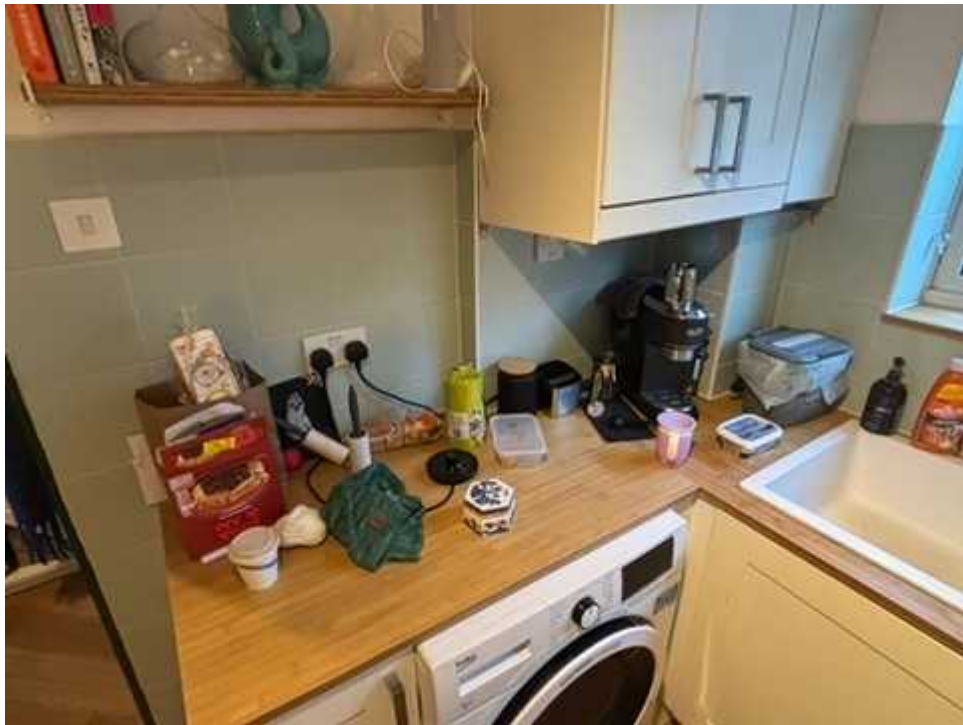
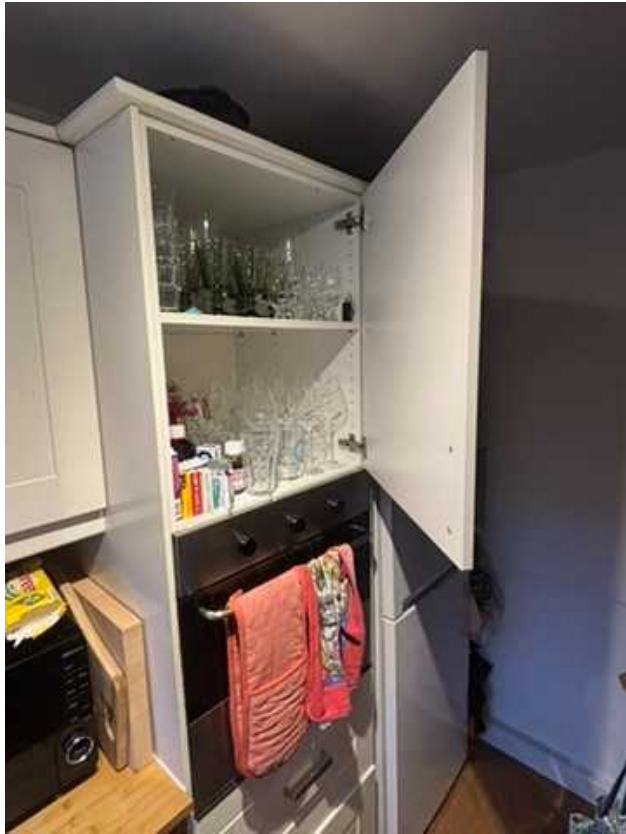
## E6 Built-in fittings (built-in kitchen and other fittings, not including appliances)

The kitchen is well-maintained, with the key elements in good condition. The sink is in good order with no visible damage. The tap is functioning properly, providing good water pressure, and there are no signs of leaks from the plumbing underneath, suggesting everything is sealed and installed correctly.

The worktop appears to be in good condition, with no signs of significant wear, damage, or staining. It is well-maintained, contributing to a clean and practical workspace. The cabinetry is also in good order, with all doors and drawers functioning smoothly and securely. There are no signs of damage, warping, or loose fittings, which suggests solid installation and ongoing care.

The tiled splashback is in good order, with no broken or missing tiles. It is functional and adds to the aesthetic of the kitchen, providing protection from moisture and stains in key areas like the cooking and sink zones.

Overall, the kitchen is in good condition, with all essential elements well-maintained. No immediate issues were identified, and the space remains functional and aesthetically pleasing. Regular cleaning and maintenance will ensure the kitchen continues to perform well.
