# Your survey report

160 Dartmath Road, London, United  
Kingdom, SE22 3LQ

21/01/2025

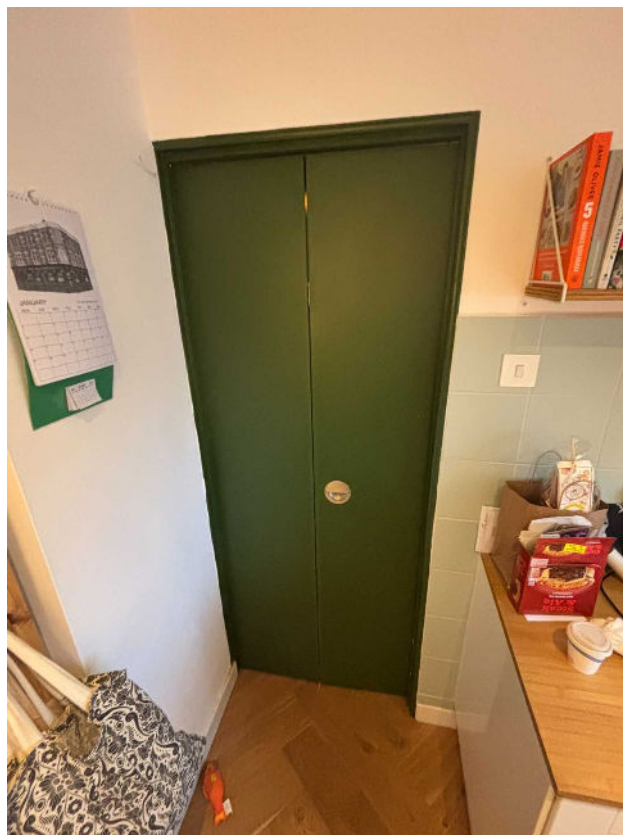
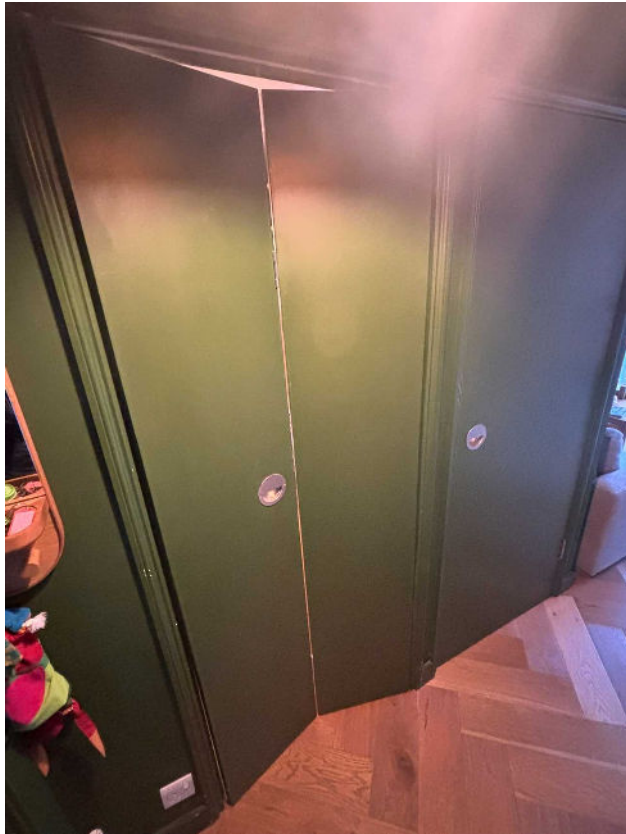
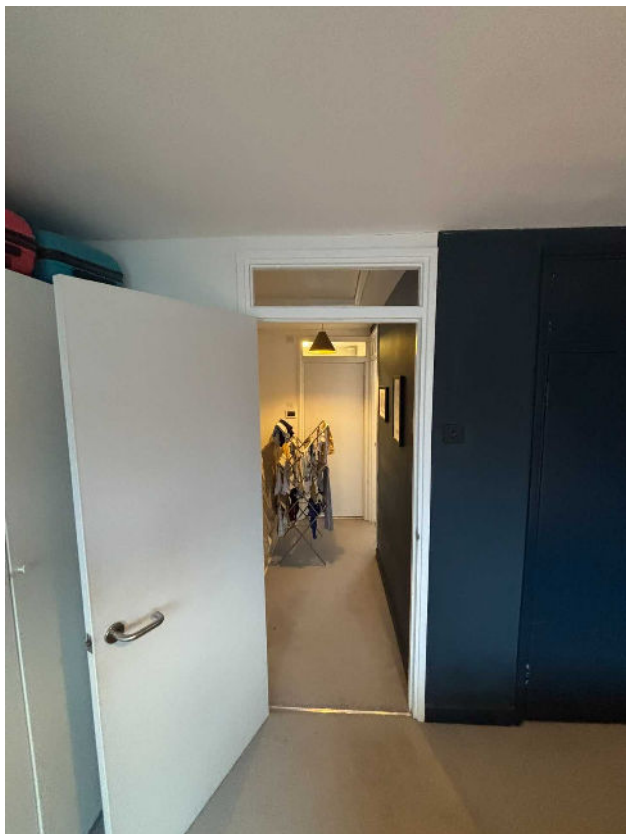
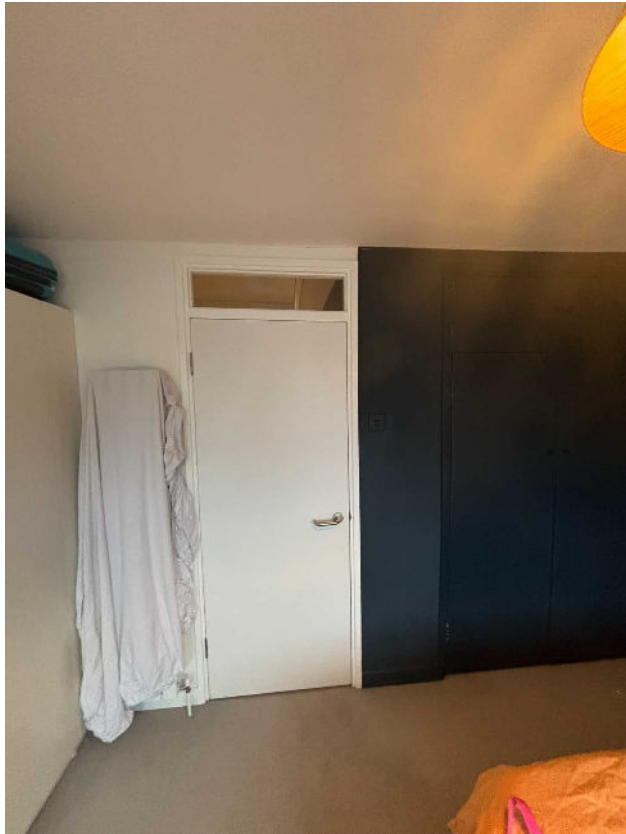
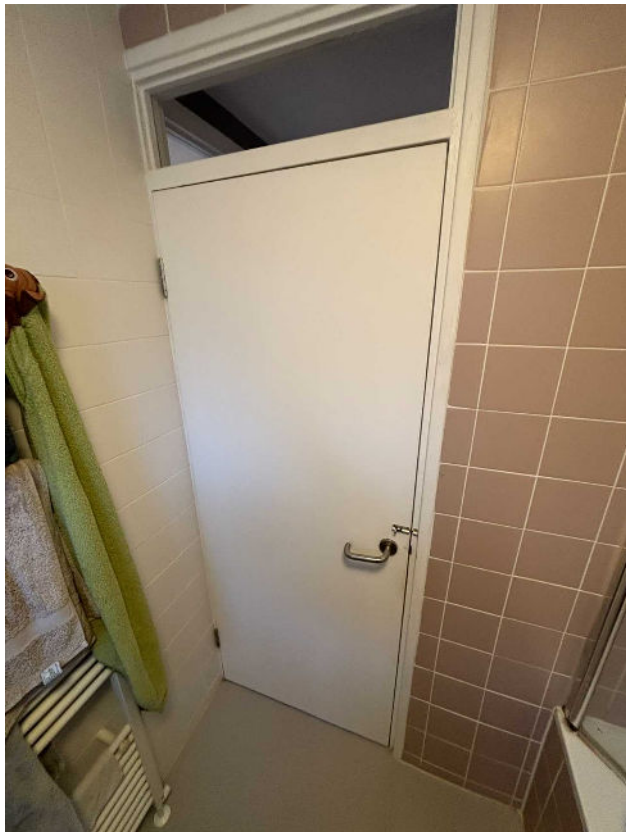
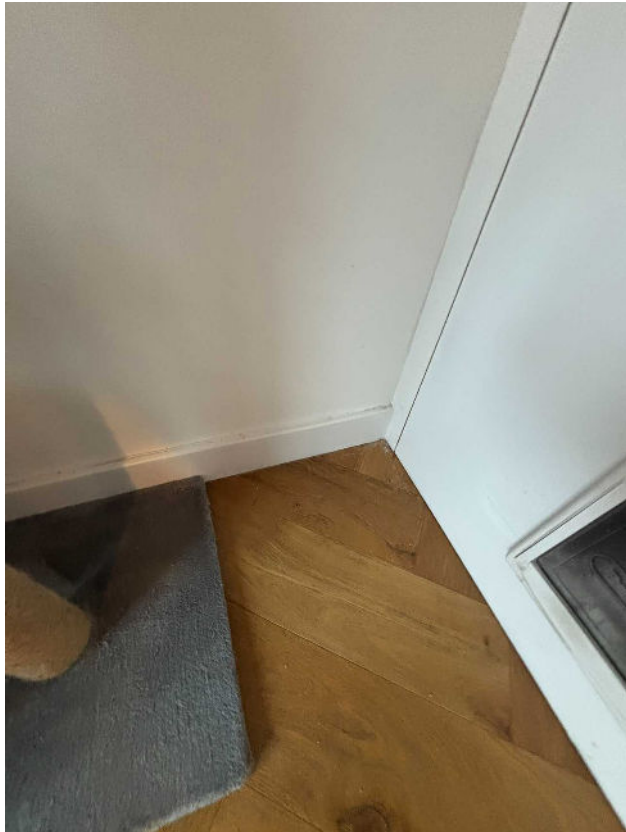
## E7 Woodwork (for example, staircase joinery)

The woodwork throughout the property is generally in good condition, with all doors, skirtings, architraves, and bannisters well-maintained. The doors are all functioning as intended, with no signs of damage or warping. The door frames, including those leading to rooms such as the bathroom and bedrooms, are securely fitted and show no significant signs of wear or damage. The painted finish on most of the doors is in good condition, providing a clean and neat appearance.

The skirtings and architraves are also in good condition, with no visible gaps or damage. The paintwork is generally well-preserved, although some minor touch-ups may be needed in high-traffic areas or where the paint has slightly worn. The architraves around doorways are well-finished and complement the overall decor of the rooms.

The bannister, visible in the stairwell, is solid and in good working order. It is securely fixed and provides adequate support for use on the stairs. There is no visible deterioration, and the paintwork on the bannister is in good condition, though a fresh coat of paint may be beneficial in areas with high wear.

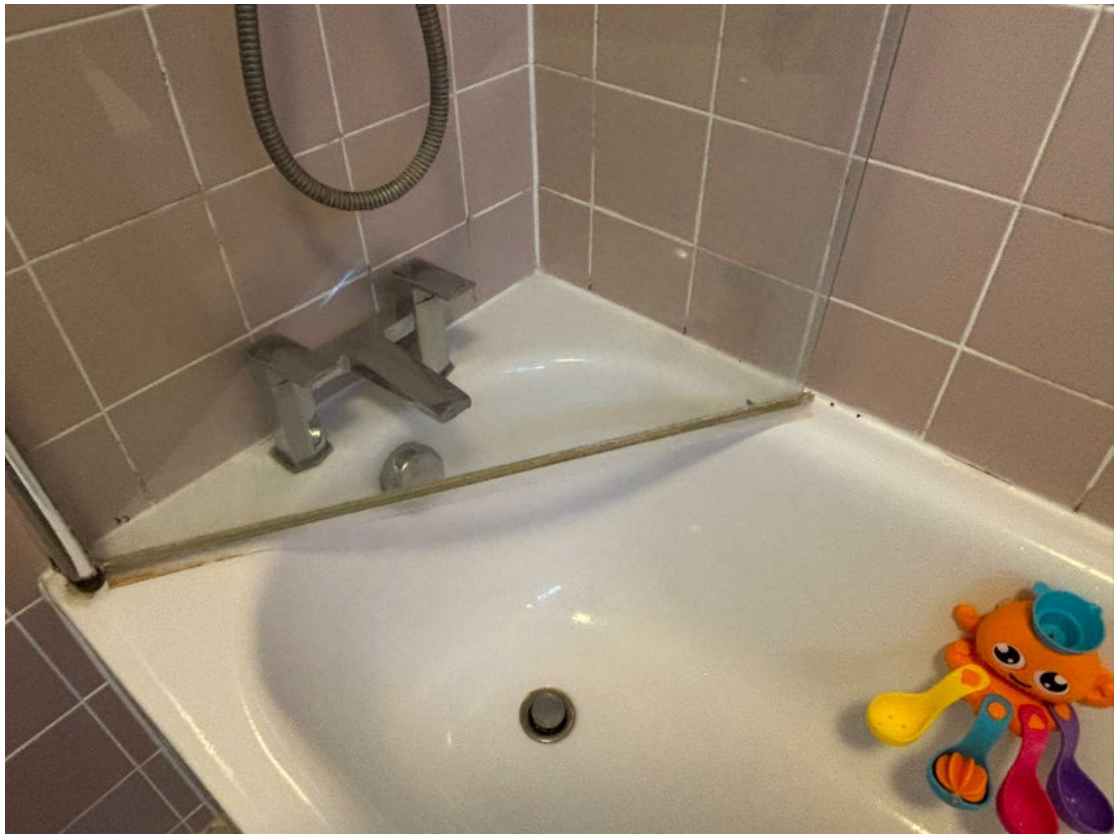
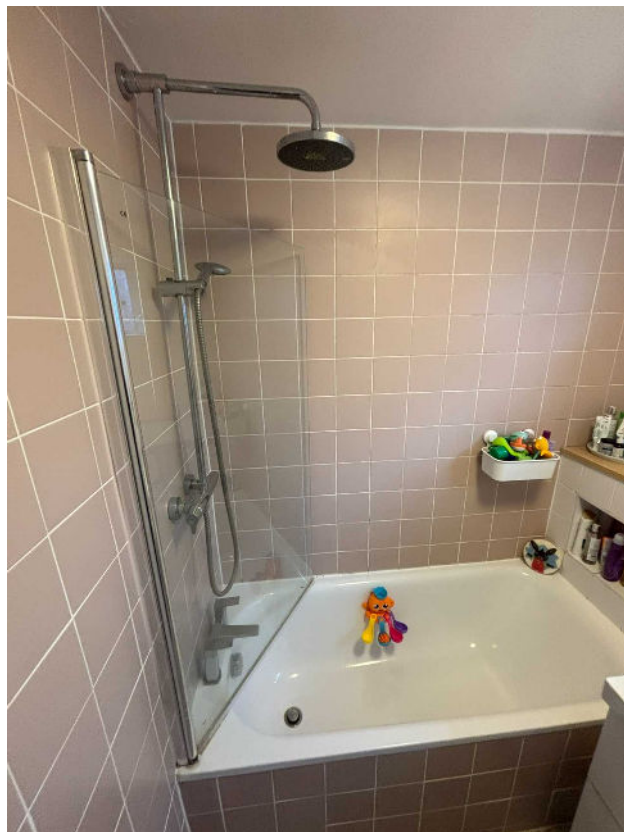
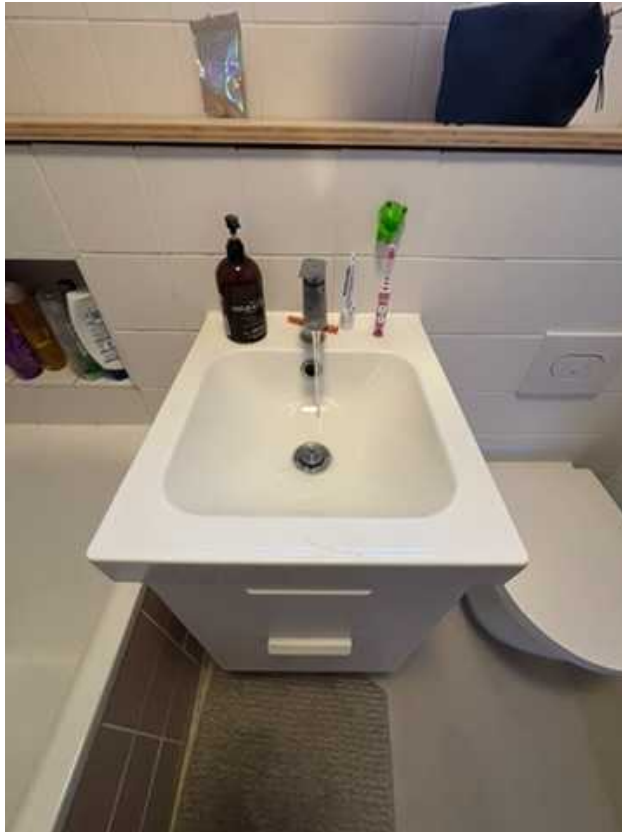
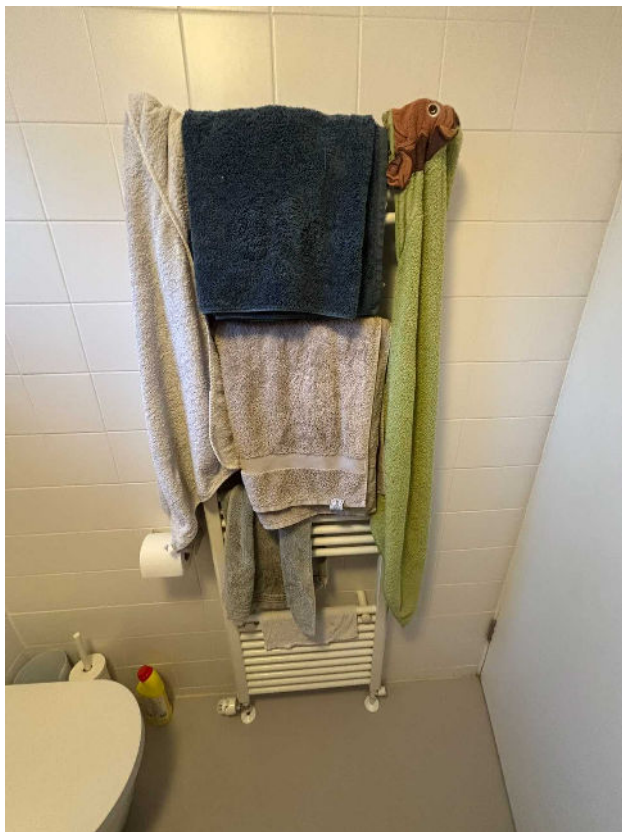
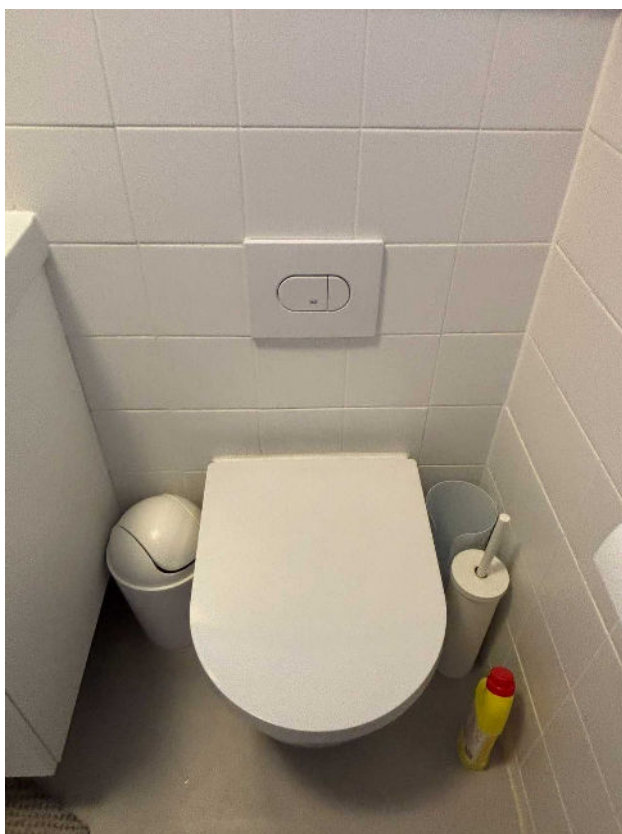
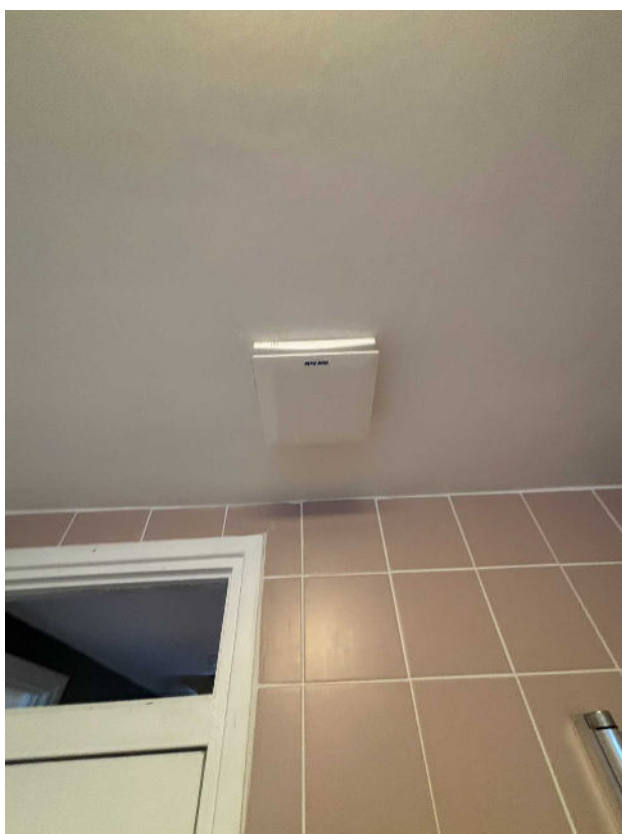
The bathroom is in good condition overall, with the sanitaryware in good order, showing no signs of damage or wear. The tiles are well-maintained, with no cracked or missing sections, and they contribute to the overall aesthetic of the room. However, the grout joints have become discoloured and show signs of minor mould growth, which suggests that a deep clean would be beneficial to restore their appearance and prevent further mould buildup.

The mastic around the bath and sink is intact, but, like the grout, it shows minor mould growth in places. This can be cleaned or replaced as part of routine maintenance to maintain hygiene and prevent any further mould spread.

The vinyl flooring in the bathroom is in good condition, with no visible damage, tears, or signs of wear. It is easy to maintain and contributes to the overall cleanliness and functionality of the space.

Overall, the bathroom is in good condition but would benefit from some deep cleaning, particularly in areas affected by mould and soap scum, to maintain its appearance and hygiene.

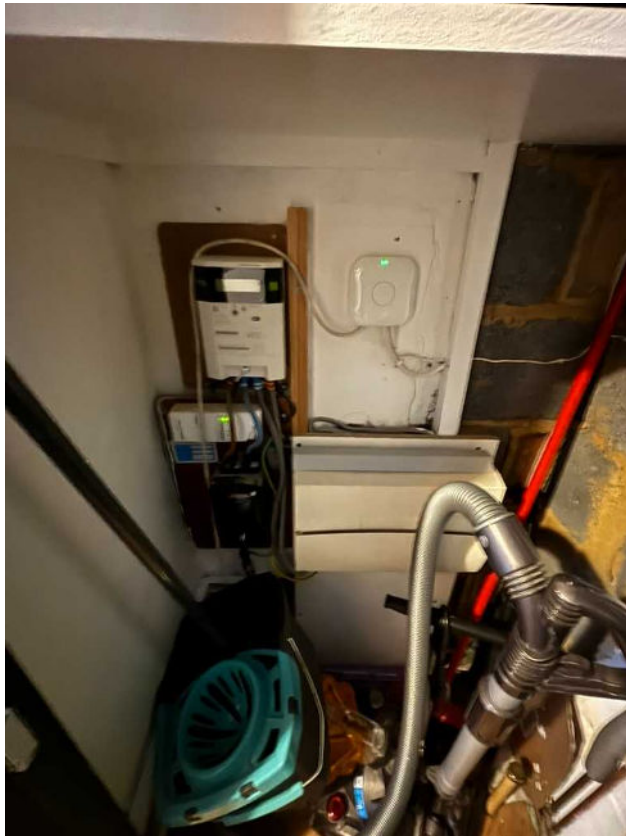
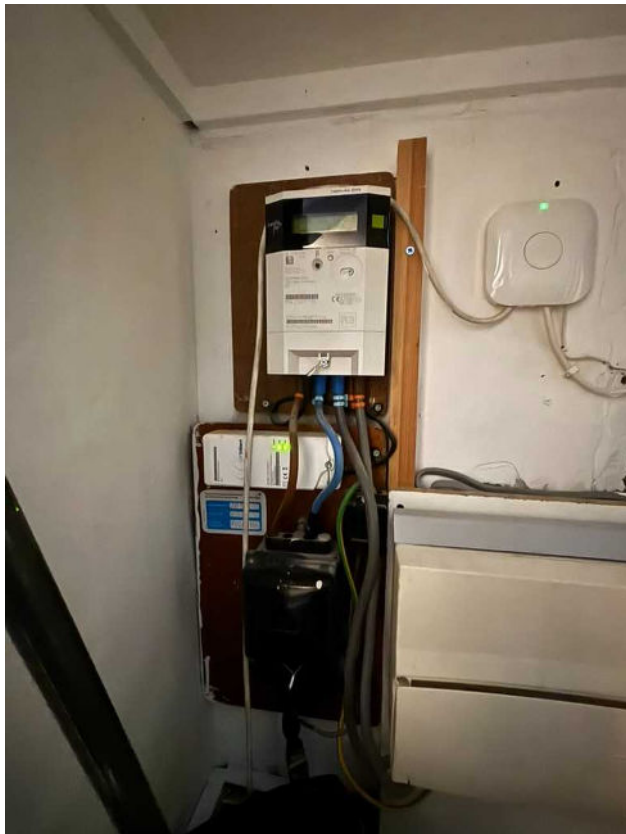
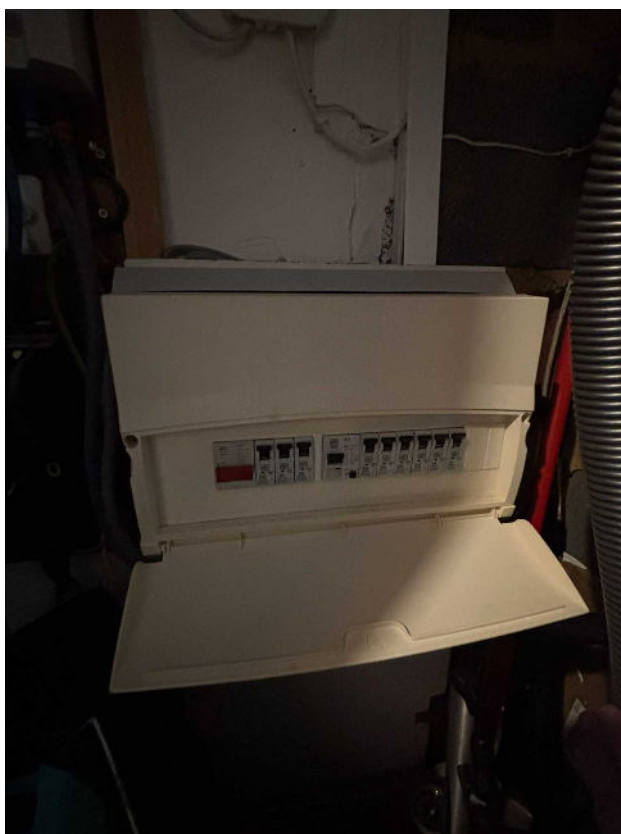
The electrical consumer unit appears to be modern and in good condition, with the necessary Residual Current Devices (RCDs) in place, providing enhanced protection against electric shocks and ensuring the safety of the electrical system. The consumer unit is well-maintained, with no visible signs of damage or wear. The electrical meter is also present and appears to be functioning properly, suggesting that the property's electricity consumption is being accurately monitored.

There is no noticeable damage to any of the sockets or light switches within the property. All seem to be securely fixed in place and free from cracks, scorch marks, or other signs of electrical issues, which is a positive indicator of the system's condition.

However, it is still advisable to request an Electrical Installation Condition Report (EICR) to ensure the electrical system is fully compliant with current safety standards and to identify any potential underlying issues that may not be immediately visible. An EICR provides a thorough assessment of the wiring and electrical installations, checking for any faults, deterioration, or hazards that could pose a risk in the future. Regular EICR checks are recommended to maintain electrical safety in any property.

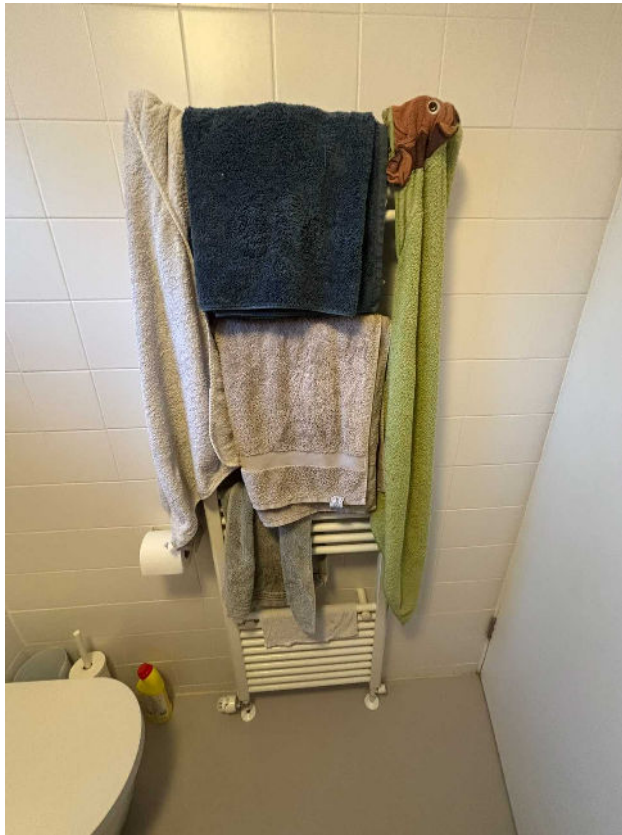
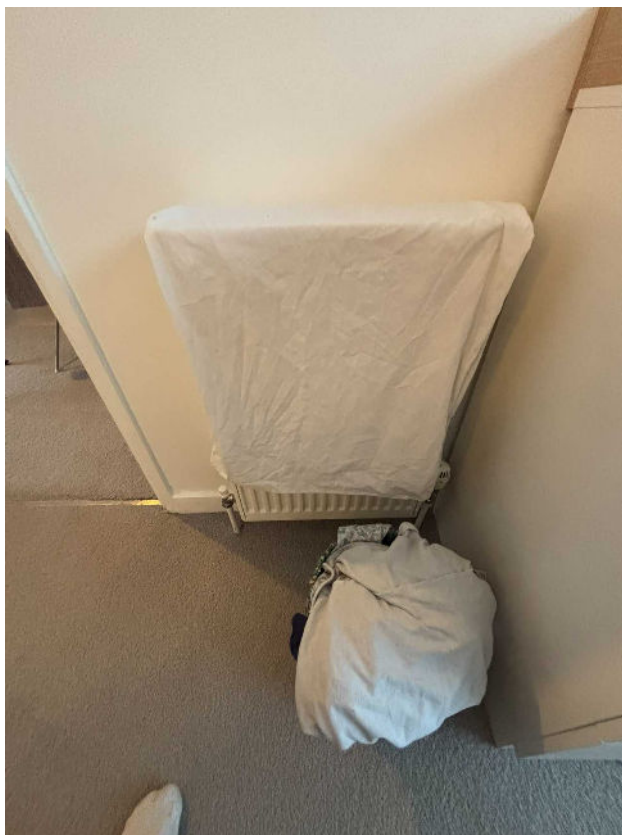
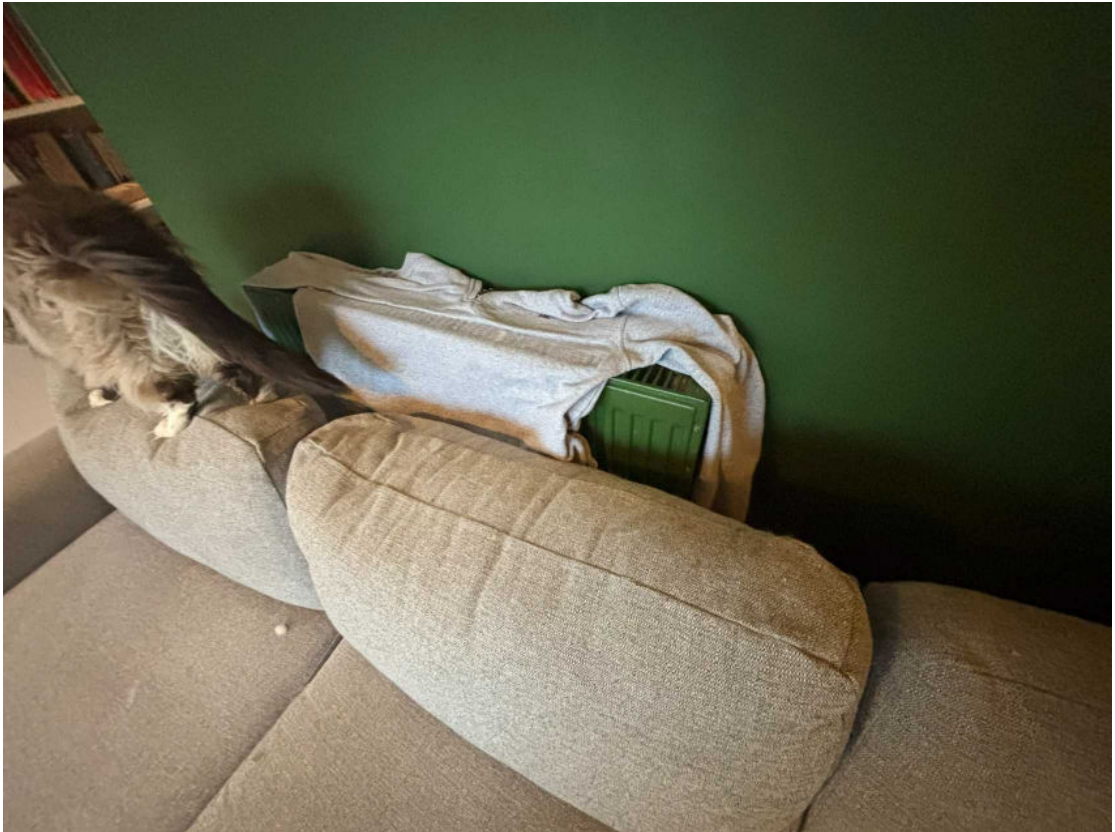
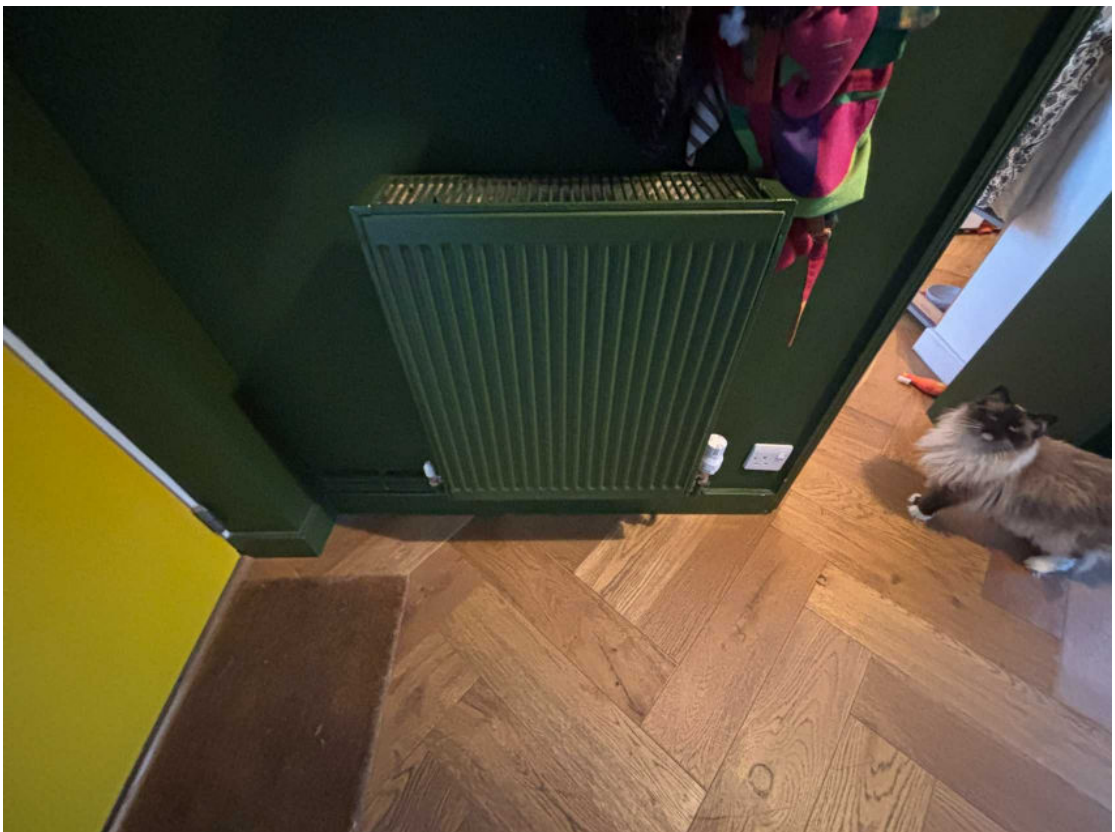
Overall, the heating system is in good working order, providing adequate warmth throughout the property. Regular maintenance, such as bleeding the radiators and checking the pressure, should be performed to ensure the system continues to operate efficiently

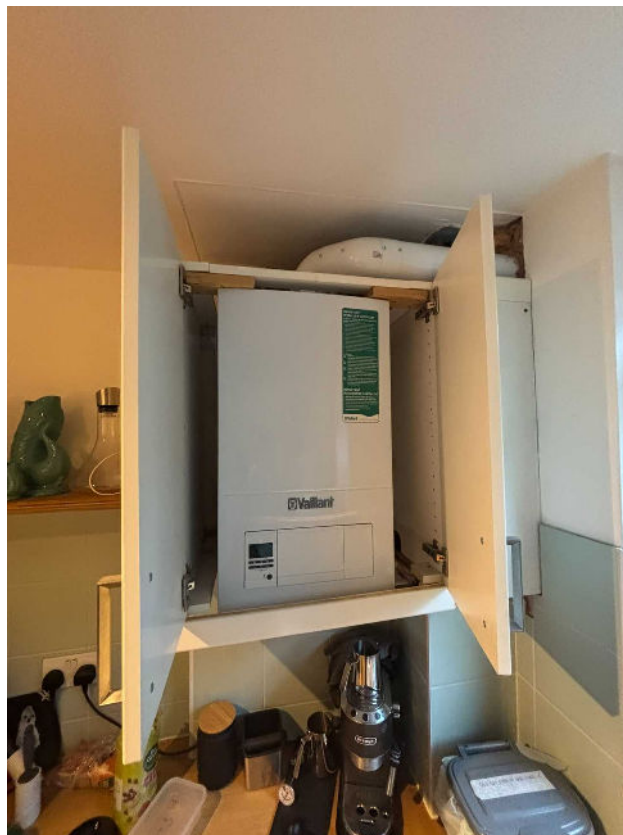
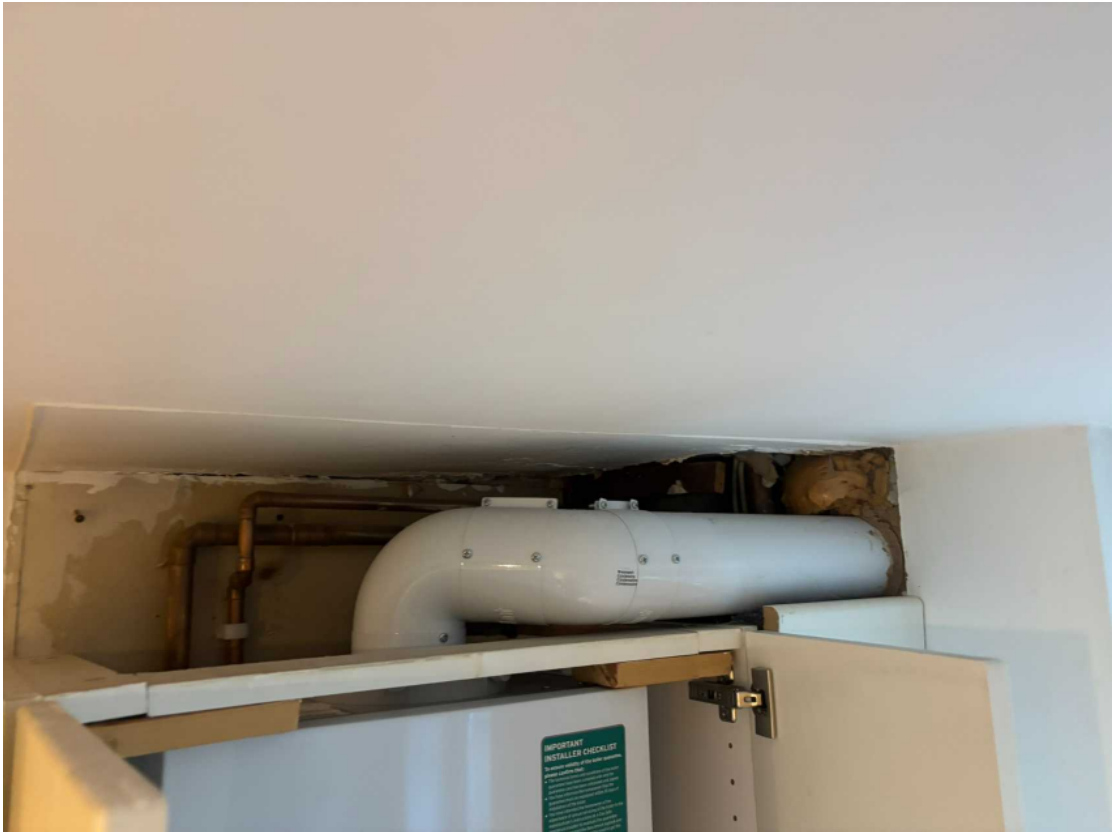
The water heating system is provided by a **combi boiler**, located in the kitchen unit. The combi boiler serves two primary functions: providing hot water for domestic use and supplying central heating throughout the property. This type of boiler is energy-efficient and space-saving, as it heats water directly from the mains when needed, without the need for a separate hot water tank.

The boiler appears to be in good condition, securely installed in its cupboard, and is well-positioned for easy access.

It is crucial to have the boiler serviced regularly to ensure it continues to operate safely and efficiently. **A Gas Safe registered engineer** should be employed to carry out the annual service and safety check, as they are qualified to inspect the gas connections and combustion systems to prevent potential hazards, such as carbon monoxide poisoning.

Additionally, you should request the **service history** of the boiler to confirm that it has been regularly maintained and check for any previous issues that may have been addressed. If the boiler is still under warranty, it is advisable to confirm the details and ensure that the necessary maintenance is carried out to avoid invalidating the warranty. A record of the warranty should be retained for any future repairs or replacement.

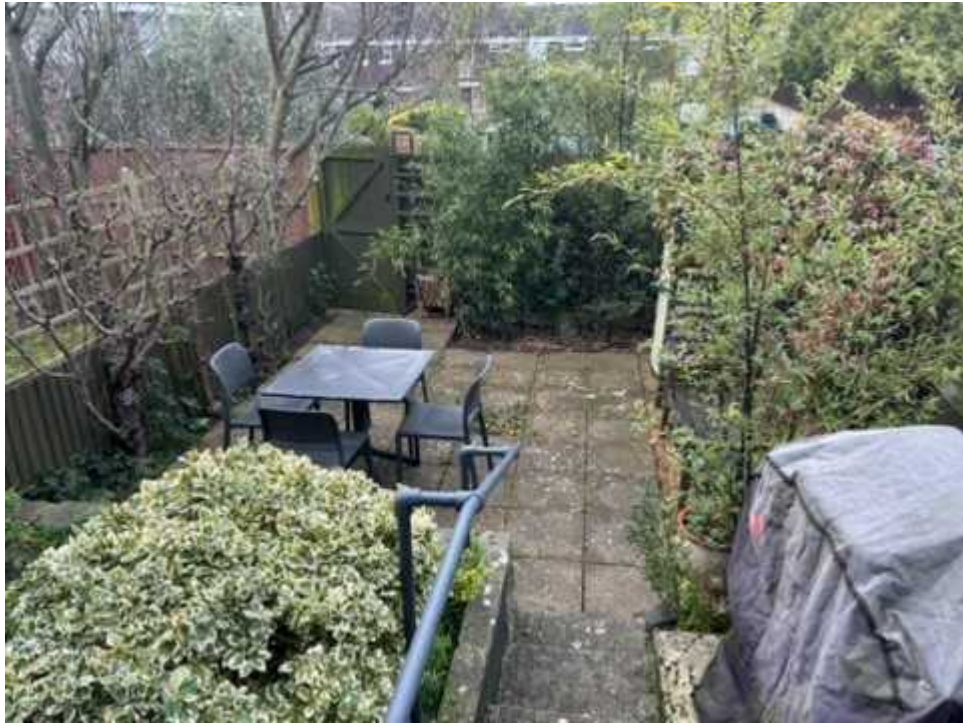
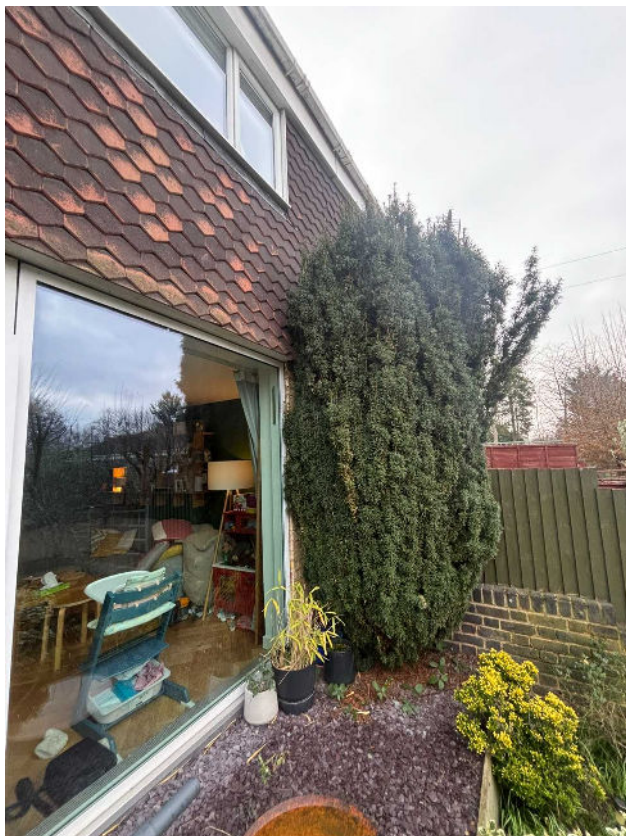
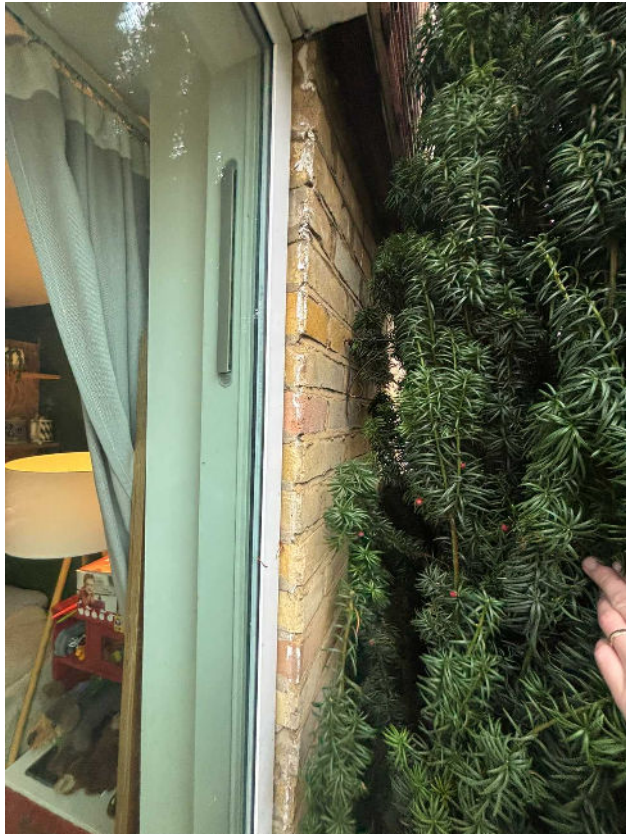
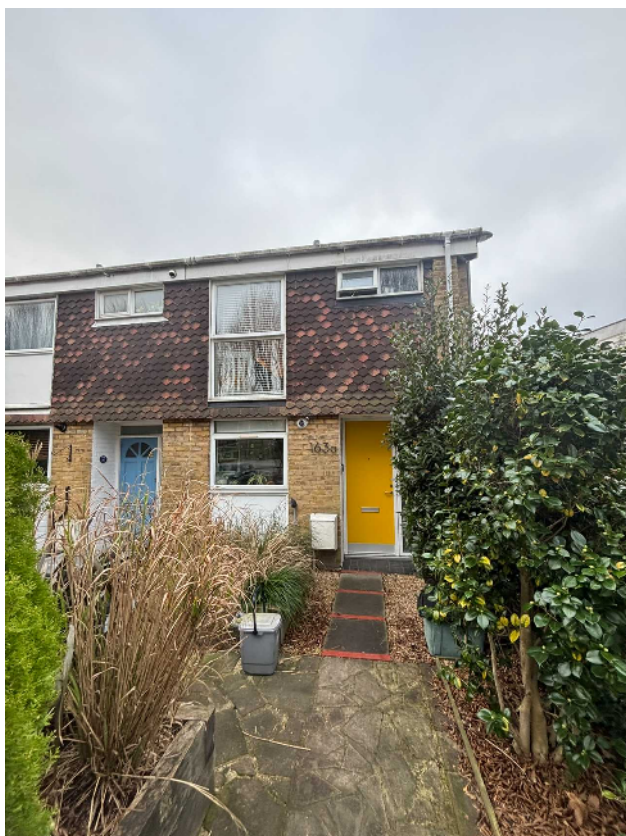
There is a **tree situated up against the side of the house**, which warrants closer attention. While the tree does not appear to be currently causing any damage, trees in close proximity to buildings can present certain risks, especially as they grow and their root systems expand.

However, there are **no visible signs of cracking or distortion** on the wall of the property in the vicinity of the tree, which suggests that the tree is **not currently causing structural issues** or damaging the building. The absence of noticeable cracks or movement is a good indication that, at present, the tree's roots or branches are not affecting the structural integrity of the property.

- **Regular Monitoring:** It is recommended that the tree be monitored regularly, especially as it matures, to ensure that its growth does not start to affect the house. If the tree shows signs of being too close to the property, its growth can be managed, or it may need to be pruned or even removed to mitigate any potential risks in the future.
- **Tree Inspection:** Consider consulting with an arborist or tree specialist who can assess the tree's proximity to the house and provide advice on whether any action is required.
